# Access Compliance Report

## Public Rights-of-Way (Curb Ramps)

Intersection ID: 53746	Main Street: SPRINGWOOD_ESTATE_DR	Cross Street: CANTERBURY_CASTLE_DR	Location: SW
ADA ID: 4AE6810F3AA6	Ramp Type: Perp	Initial Pass/Fail: Fail	Overall Compliance: No
Codes/Mitigation Info/Possible Solution			Severity Score: 25
			Field Measurements/Component Compliance

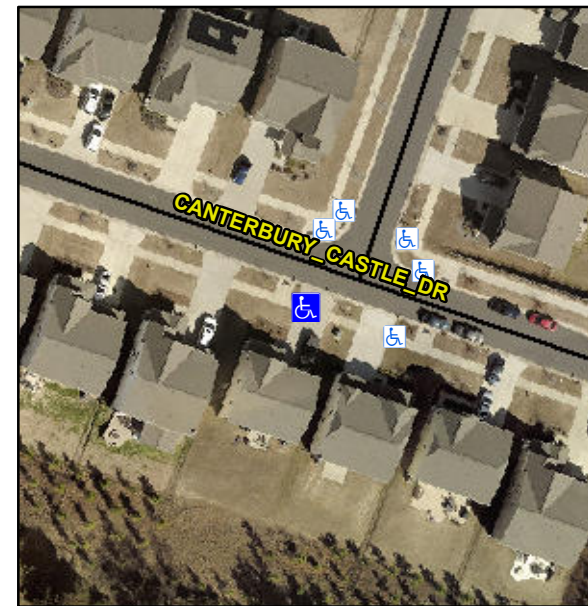
Compliance	Description	Data	Compliance	Description	Data
N/A	Ramp Length (in)	96.0	Yes	Ramp Slope (%)	6.5
Yes	Ramp Width (in)	48.0	No	Ramp XSlope (%)	8.0
N/A	Flare Type LT	N/A	N/A	Flare Type RT	N/A
N/A	Flare Slope LT (%)	N/A	N/A	Flare Slope RT (%)	N/A
N/A	Flare Traversable LT?	N/A	N/A	Flare Traversable RT?	N/A
N/A	Landing Length (in)	N/A	N/A	DWS Provided?	N/A
N/A	Landing Width (in)	N/A	N/A	DWS Contrast?	N/A
N/A	Landing Slope (%)	N/A	N/A	DWS Length (in)	N/A
N/A	Landing X Slope (%)	N/A	N/A	DWS Full Width?	N/A
N/A	Landing Curb? (Y/N)	N/A	N/A	DWS Offset (in)	N/A
N/A	Shared Landing?	N/A			
N/A	Gutter Ponding?	N/A	N/A	Gutter Slope (%)	N/A
N/A	Gutter Lip Ht (in)	N/A	N/A	Gutter X Slope (%)	N/A
N/A	Painted X Walk1?	No	N/A	Painted X Walk2?	N/A
	X Walk 1 Direction	To NE		X Walk 2 Direction	N/A
N/A	X Walk 1 Width (in)	N/A	N/A	X Walk 2 Width (in)	N/A
	X Walk 1 Slope (%)	1.8		X Walk 2 Slope (%)	N/A
	X Walk 1 X Slope (%)	3.8		X Walk 2 X Slope (%)	N/A

N/A	Ramp inside XWalk1?	N/A	N/A	Ramp inside XWalk2?	N/A
	Road Slope (%)	N/A	N/A	Clear Space?	N/A
	Road X Slope (%)	N/A	N/A	Clear Space to XWalk (in)	N/A
N/A	Any Obstructions?	N/A	N/A	Storm Grate/Utility Hazard?	N/A
	Obstruction Type			Storm Grate/Utility Type	
		N/A			N/A
			Yes	Surface Condition? (G/P)	Good

Possible Solutions:

**Remove & Replace Entire Ramp.**

**R304.5.3**
