# Access Compliance Report

## Public Rights-of-Way

### (Curb Ramps)

Intersection ID: 3878	Main Street: BRIGHTLEAF_PL	Cross Street: DEER_CROSS_TL	Location: NE
ADA ID: 4AF38C71753C	Ramp Type: BlendTrans1	Initial Pass/Fail: Fail	Overall Compliance: No
		Severity Score: 10

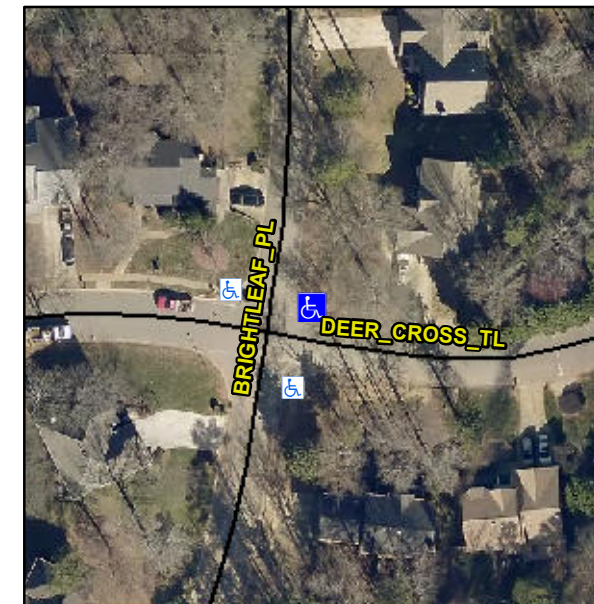
**Not Found, R304.5.1, R304.5.3**

Compliance	Description	Data	Compliance	Description	Data
N/A	Ramp Length (in)	93.0	Yes	BlendTrans Slope (%)	4.7
No	Ramp Width (in)	36.0	No	BlendTrans XSlope (%)	2.8
N/A	Flare Type LT	N/A	N/A	Flare Type RT	N/A
N/A	Flare Slope LT (%)	N/A	N/A	Flare Slope RT (%)	N/A
N/A	Flare Traversable LT?	N/A	N/A	Flare Traversable RT?	N/A
N/A	Landing Length (in)	N/A	N/A	DWS Provided?	N/A
N/A	Landing Width (in)	N/A	N/A	DWS Contrast?	N/A
N/A	Landing Slope (%)	N/A	N/A	DWS Length (in)	N/A
N/A	Landing X Slope (%)	N/A	N/A	DWS Full Width?	N/A
N/A	Landing Curb? (Y/N)	N/A	N/A	DWS Offset (in)	N/A
N/A	Shared Landing?	N/A			
N/A	Gutter Ponding?	N/A	N/A	Gutter Slope (%)	N/A
N/A	Gutter Lip Ht (in)	N/A	N/A	Gutter X Slope (%)	N/A
N/A	Painted X Walk1?	No	N/A	Painted X Walk2?	No
	X Walk 1 Direction	To W		X Walk 2 Direction	To S
	X Walk 1 Width (in)	N/A		X Walk 2 Width (in)	N/A
	X Walk 1 Slope (%)	5.2		X Walk 2 Slope (%)	8.6
	X Walk 1 X Slope (%)	2.2		X Walk 2 X Slope (%)	1.0

N/A	Ramp inside XWalk1?	N/A	N/A	Ramp inside XWalk2?	N/A
	Road Slope (%)	1.5		Clear Space?	N/A
	Road X Slope (%)	4.7	N/A	Clear Space to XWalk (in)	N/A
N/A	Any Obstructions?	N/A	N/A	Storm Grate/Utility Hazard?	N/A
	Obstruction Type			Storm Grate/Utility Type	
		N/A			N/A
			Yes	Surface Condition? (G/P)	Good
			No	Curb Slope (%)	8.3

**Remove & Replace Curb Ramp With Two New Directional Ramps or Equivalent.**
