# Access Compliance Report

## Public Rights-of-Way

### (Curb Ramps)

| Intersection ID: 11985 | Main Street: MCGILL_GARDEN_WY | Cross Street: N_DAVIDSON_ST | Location: E |

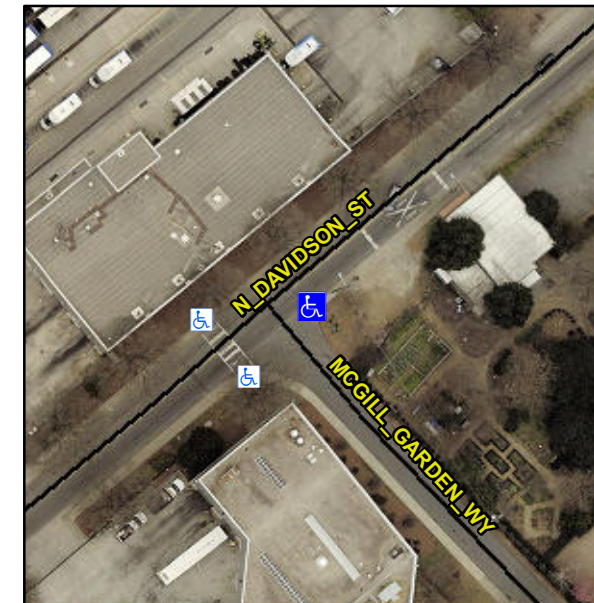
| ADA ID: 4AFD86EB00A9 | Ramp Type: Directional1 | Initial Pass/Fail: Pass | Overall Compliance: No |
| | | Severity Score: 22.5 | |

**R304.2.1, R304.5.3, R305.1.4, R305.2,  
R302.7, R302.7.2, R304.5.4**

| Compliance | Description | Data | Compliance | Description | Data |
|---|---|---|---|---|---|
| No | Landing Width (in) | 45.0 | Yes | DWS Contrast? | Yes |
| No | Landing X Slope (%) | 3.2 | No | DWS Full Width? | No |
| No | Gutter Ponding? | Yes | No | Gutter Slope (%) | 6.2 |
| No | Gutter Lip Ht (in) | 1.5 | No | Gutter X Slope (%) | 2.1 |

Possible Solutions:

**Remove & Replace Entire Ramp.  
Remove & Replace Gutter.**
