## Access Compliance Report Public Rights-of-Way (Curb Ramps)

Intersection ID: 26032 Main Street: CABOT\_CR Cross Street: CARMEL\_COMMONS\_BV Location: SE

ADA ID: 4B0B986E1FBF Ramp Type: PerpDiag Initial Pass/Fail: Fail Overall Compliance: No Severity Score: 13.75

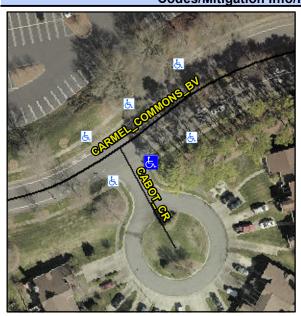
Not Found, R304.2.2, R304.5.3

Compliance Description Data Compliance Description Data No N/A Ramp Length (in) 74.0 Ramp Slope (%) 10.5 104.0 No Ramp XSlope (%) Yes Ramp Width (in) 3.3 N/A N/A Flare Type LT N/A Flare Type RT N/A N/A N/A Flare Slope RT (%) N/A Flare Slope LT (%) N/A N/A Flare Traversable LT? N/A N/A Flare Traversable RT? N/A N/A N/A N/A **DWS Provided?** N/A Landing Length (in) N/A Landing Width (in) N/A N/A **DWS Contrast?** N/A N/A N/A N/A Landing Slope (%) DWS Length (in) N/A N/A Landing X Slope (%) N/A N/A DWS Full Width? N/A N/A Landing Curb? (Y/N) N/A N/A DWS Offset (in) N/A N/A N/A Shared Landing? N/A **Gutter Ponding?** N/A N/A Gutter Slope (%) N/A N/A Gutter Lip Ht (in) N/A N/A Gutter X Slope (%) N/A N/A Painted X Walk1? No N/A Painted X Walk2? No X Walk 1 Direction To N X Walk 2 Direction To W N/A N/A X Walk 2 Width (in) X Walk 1 Width (in) N/A X Walk 1 Slope (%) X Walk 2 Slope (%) 1.8 0.1 X Walk 2 X Slope (%) X Walk 1 X Slope (%) 1.1 0.5 N/A N/A N/A Ramp inside XWalk2? N/A Ramp inside XWalk1? Road Slope (%) 1.1 N/A Clear Space? N/A N/A Road X Slope (%) 1.5 Clear Space to XWalk (in) N/A N/A N/A N/A Any Obstructions? Storm Grate/Utility Hazard? N/A **Obstruction Type** Storm Grate/Utility Type N/A N/A

Remove & Replace Curb Ramp With Two New Directional Ramps or Equivalent.
