# Access Compliance Report

## Public Rights-of-Way

### (Curb Ramps)

Intersection ID: 7330	Main Street: HEATHERBROOKE_AV	Cross Street: PONDELLA_DR	Location: SE
ADA ID: 4B321E24B860	Ramp Type: Perp	Initial Pass/Fail: Fail	Overall Compliance: No
Severity Score: 21.25			
Codes/Mitigation Info/Possible Solution		Field Measurements/Component Compliance

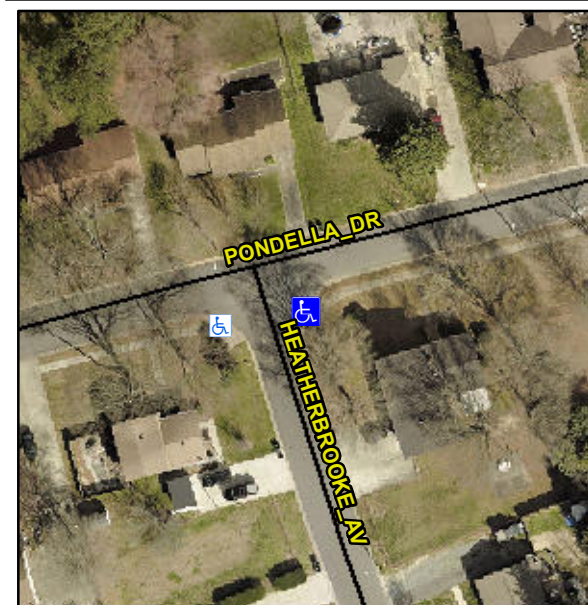
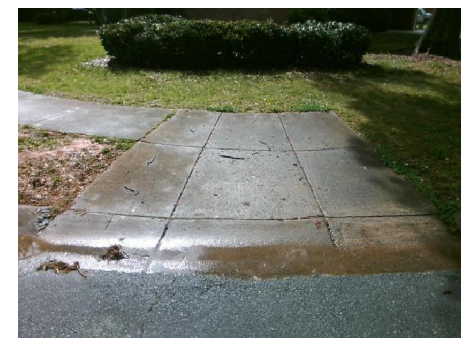
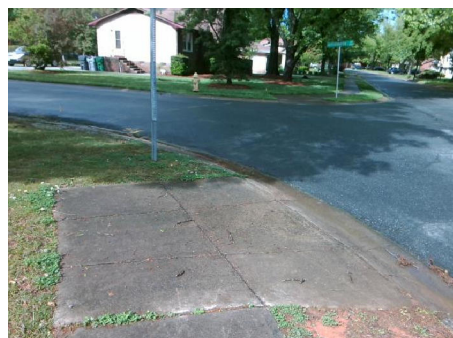
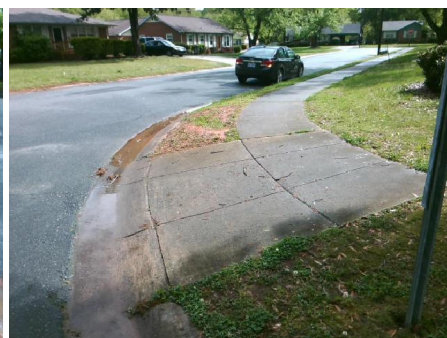
**Not Found, R304.5.1, R304.2.2**

Compliance	Description	Data	Compliance	Description	Data
N/A	Ramp Length (in)	48.0	No	Ramp Slope (%)	10.1
No	Ramp Width (in)	40.0	Yes	Ramp XSlope (%)	0.7
N/A	Flare Type LT	N/A	N/A	Flare Type RT	N/A
N/A	Flare Slope LT (%)	N/A	N/A	Flare Slope RT (%)	N/A
N/A	Flare Traversable LT?	N/A	N/A	Flare Traversable RT?	N/A
N/A	Landing Length (in)	N/A	N/A	DWS Provided?	N/A
N/A	Landing Width (in)	N/A	N/A	DWS Contrast?	N/A
N/A	Landing Slope (%)	N/A	N/A	DWS Length (in)	N/A
N/A	Landing X Slope (%)	N/A	N/A	DWS Full Width?	N/A
N/A	Landing Curb? (Y/N)	N/A	N/A	DWS Offset (in)	N/A
N/A	Shared Landing?	N/A			
N/A	Gutter Ponding?	N/A	N/A	Gutter Slope (%)	N/A
N/A	Gutter Lip Ht (in)	N/A	N/A	Gutter X Slope (%)	N/A
N/A	Painted X Walk1?	No	N/A	Painted X Walk2?	N/A
	X Walk 1 Direction	To W		X Walk 2 Direction	N/A
N/A	X Walk 1 Width (in)	N/A	N/A	X Walk 2 Width (in)	N/A
	X Walk 1 Slope (%)	2.6		X Walk 2 Slope (%)	N/A
	X Walk 1 X Slope (%)	0.0		X Walk 2 X Slope (%)	N/A

N/A	Ramp inside XWalk1?	N/A	N/A	Ramp inside XWalk2?	N/A
	Road Slope (%)	N/A	N/A	Clear Space?	N/A
	Road X Slope (%)	N/A	N/A	Clear Space to XWalk (in)	N/A
N/A	Any Obstructions?	N/A	N/A	Storm Grate/Utility Hazard?	N/A
	Obstruction Type			Storm Grate/Utility Type	
		N/A			N/A
			Yes	Surface Condition? (G/P)	Good

**Remove & Replace Entire Ramp.**
