## Access Compliance Report Public Rights-of-Way (Curb Ramps)

NI)A/	
Intersection ID: 25762 Main S	Main Street: CHARTER_OAK_LN		Cross Street: PINEVILLE-MATTHEWS_RD				Location:	NW	
ADA ID: 4B33B1A55F9B Ramp	9B Ramp Type: PerpDiag		nitial Pass/Fail: Fail Overall Compliance: I				o Severity Score:	31.25	
Codes/Mitigation Info/Possible Solution			Field Measurements/Component Compliance						
RUE VILLE RUE TUE DE LE	Possible Solutions:	<u>C</u>	Compliance Description			Data Compliance Description			
	Remove & Replace Curb Ramp With Two New Directional Ramps or Equivalent.	ith N/	A Ramp	Length (in)	57.0	No	Ramp Slope (%)	9.6	
		No	Ramp	Width (in)	35.0	No	Ramp XSlope (%)	2.9	
		N/.	A Flare	Type LT	N/A	N/A	Flare Type RT	N/A	
		N/	A Flare	Slope LT (%)	N/A	N/A	Flare Slope RT (%)	N/A	
		N/	A Flare	Traversable LT?	N/A	N/A	Flare Traversable RT?	N/A	
		N/	<b>A</b> Landin	ig Length (in)	N/A	N/A	DWS Provided?	N/A	
	Surveyor Notes:	N/	A Landin	ng Width (in)	N/A	N/A	DWS Contrast?	N/A

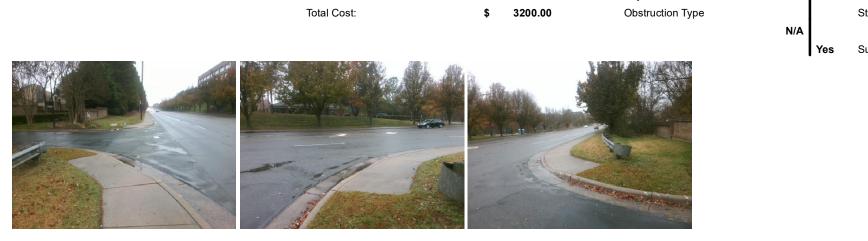
N/A	N/	<b>A</b> Landin	ng Slope (%)	N/A	N/A	DWS Length (in)	N/A	
		N/	A Landin	ig X Slope (%)	N/A	N/A	DWS Full Width?	N/A	
		N/	<b>A</b> Landin	ng Curb? (Y/N)	N/A	N/A	DWS Offset (in)	N/A	
		N/	A Share	d Landing?	N/A				
	PROW/ADA:		A Gutter	Ponding?	N/A	N/A	Gutter Slope (%)	N/A	
A CONTRACTOR OF A CONTRACTOR O	Not Found, R304.5.1, R304.2.2,	N/.	A Gutter	Lip Ht (in)	N/A	N/A	Gutter X Slope (%)	N/A	
	R304.5.3	N/	A Painte	d X Walk1?	No	N/A	Painted X Walk2?	No	
	No.		X Wall	A 1 Direction	To S		X Walk 2 Direction	To E	
		N/	A X Wall	< 1 Width (in)	N/A	N/A	X Walk 2 Width (in)	N/A	
Street 1 Name PINEVILLE-MATTHEWS RD			X Wall	<pre>x 1 Slope (%)</pre>	2.1		X Walk 2 Slope (%)	2.8	
Stop Condition-Street 2 None			X Wall	< 1 X Slope (%)	1.8		X Walk 2 X Slope (%)	3.6	
Street 2 Name CHARTER OAK LN		N/	A Ramp	inside XWalk1?	N/A	N/A	Ramp inside XWalk2?	N/A	
Stop Condition-Street 1 StopSigr			Road	Slope (%)	1.2	N/A	Clear Space?	N/A

Road 2	X Slope (%)	1.8	N/A	Clear Space to XWalk (in)	N/A	
		N/	A Any O	bstructions?	N/A	N/A	Storm Grate/Utility Hazard?	N/A	
	Total Cost: \$ 32	00.00	Obstru	uction Type			Storm Grate/Utility Type		
					N/A			N/A
