# Access Compliance Report

## Public Rights-of-Way

### (Curb Ramps)

Intersection ID: 4968	Main Street: CARMATHEN_RD	Cross Street: GLAMORGAN_CT	Location: SE
ADA ID: 4B3CC267E9CF	Ramp Type: Perp	Initial Pass/Fail: Fail	Overall Compliance: No
Severity Score: 8.75			
Codes/Mitigation Info/Possible Solution		Field Measurements/Component Compliance

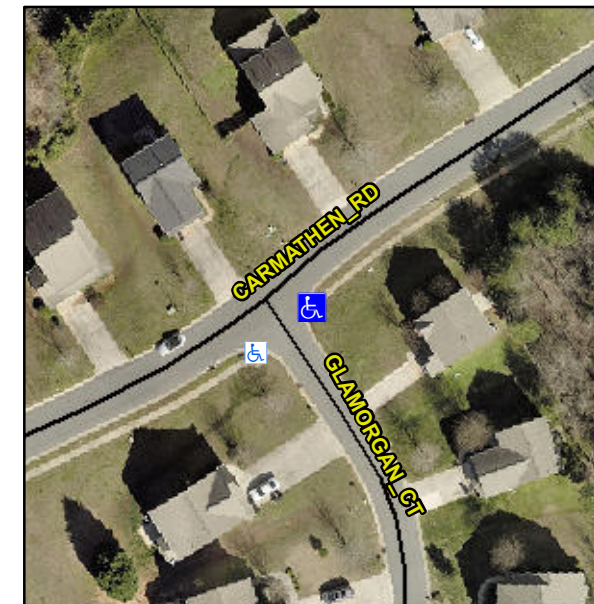
Compliance	Description	Data	Compliance	Description	Data
N/A	Ramp Length (in)	48.5	Yes	Ramp Slope (%)	7.7
No	Ramp Width (in)	38.0	Yes	Ramp XSlope (%)	0.9
N/A	Flare Type LT	N/A	N/A	Flare Type RT	N/A
N/A	Flare Slope LT (%)	N/A	N/A	Flare Slope RT (%)	N/A
N/A	Flare Traversable LT?	N/A	N/A	Flare Traversable RT?	N/A
N/A	Landing Length (in)	N/A	N/A	DWS Provided?	N/A
N/A	Landing Width (in)	N/A	N/A	DWS Contrast?	N/A
N/A	Landing Slope (%)	N/A	N/A	DWS Length (in)	N/A
N/A	Landing X Slope (%)	N/A	N/A	DWS Full Width?	N/A
N/A	Landing Curb? (Y/N)	N/A	N/A	DWS Offset (in)	N/A
N/A	Shared Landing?	N/A			
N/A	Gutter Ponding?	N/A	N/A	Gutter Slope (%)	N/A
N/A	Gutter Lip Ht (in)	N/A	N/A	Gutter X Slope (%)	N/A
N/A	Painted X Walk1?	No	N/A	Painted X Walk2?	N/A
	X Walk 1 Direction	To W		X Walk 2 Direction	N/A
N/A	X Walk 1 Width (in)	N/A	N/A	X Walk 2 Width (in)	N/A
	X Walk 1 Slope (%)	8.1		X Walk 2 Slope (%)	N/A
	X Walk 1 X Slope (%)	1.0		X Walk 2 X Slope (%)	N/A

N/A	Ramp inside XWalk1?	N/A	N/A	Ramp inside XWalk2?	N/A
	Road Slope (%)	N/A	N/A	Clear Space?	N/A
	Road X Slope (%)	N/A	N/A	Clear Space to XWalk (in)	N/A
N/A	Any Obstructions?	N/A	N/A	Storm Grate/Utility Hazard?	N/A
	Obstruction Type			Storm Grate/Utility Type	
		N/A			N/A
			Yes	Surface Condition? (G/P)	Good

Possible Solutions:

**Remove & Replace Entire Ramp.**

**Not Found, R304.5.1**
