Access Compliance Report

Public Rights-of-Way

(Curb Ramps)

Intersection ID: 48462	Main Street: PANGLEMONT_DR	Cross Street: MITZI_DEBORAH_LN	Location:	S
ADA ID: 4B42ADE870EE	Ramp Type: Perp	Initial Pass/Fail: Fail	Overall Compliance: No	Severity Score: 10

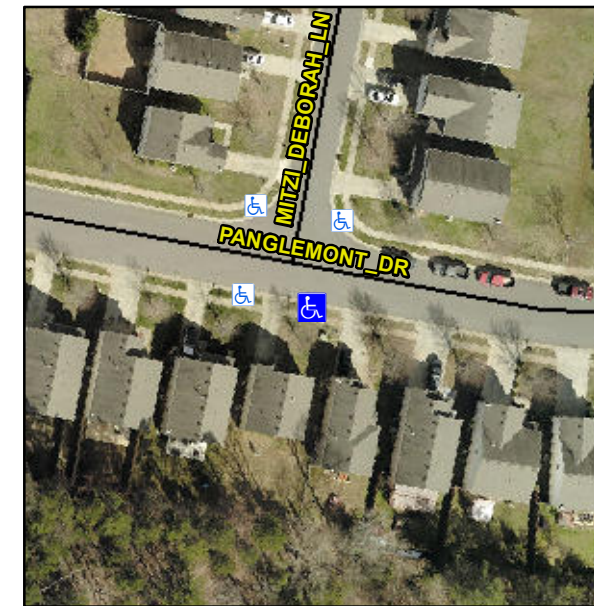
Not Found, R304.5.1, R304.5.3

Compliance	Description	Data	Compliance	Description	Data
N/A	Ramp Length (in)	47.5	Yes	Ramp Slope (%)	6.6
No	Ramp Width (in)	47.5	No	Ramp XSlope (%)	4.5
N/A	Flare Type LT	N/A	N/A	Flare Type RT	N/A
N/A	Flare Slope LT (%)	N/A	N/A	Flare Slope RT (%)	N/A
N/A	Flare Traversable LT?	N/A	N/A	Flare Traversable RT?	N/A
N/A	Landing Length (in)	N/A	N/A	DWS Provided?	N/A
N/A	Landing Width (in)	N/A	N/A	DWS Contrast?	N/A
N/A	Landing Slope (%)	N/A	N/A	DWS Length (in)	N/A
N/A	Landing X Slope (%)	N/A	N/A	DWS Full Width?	N/A
N/A	Landing Curb? (Y/N)	N/A	N/A	DWS Offset (in)	N/A
N/A	Shared Landing?	N/A			
N/A	Gutter Ponding?	N/A	N/A	Gutter Slope (%)	N/A
N/A	Gutter Lip Ht (in)	N/A	N/A	Gutter X Slope (%)	N/A
N/A	Painted X Walk1?	No	N/A	Painted X Walk2?	N/A
	X Walk 1 Direction	To NE		X Walk 2 Direction	N/A
N/A	X Walk 1 Width (in)	N/A	N/A	X Walk 2 Width (in)	N/A
	X Walk 1 Slope (%)	2.0		X Walk 2 Slope (%)	N/A
	X Walk 1 X Slope (%)	3.8		X Walk 2 X Slope (%)	N/A

N/A	Ramp inside XWalk1?	N/A	N/A	Ramp inside XWalk2?	N/A
	Road Slope (%)	N/A	N/A	Clear Space?	N/A
	Road X Slope (%)	N/A	N/A	Clear Space to XWalk (in)	N/A
N/A	Any Obstructions?	N/A	N/A	Storm Grate/Utility Hazard?	N/A
	Obstruction Type			Storm Grate/Utility Type	
		N/A			N/A
			Yes	Surface Condition? (G/P)	Good

Remove & Replace Entire Ramp.
