Access Compliance Report Public Rights-of-Way (Curb Ramps)

Intersection ID: 32157	2157 Main Street: NOLAND_WOODS_DR				TALBERT_PAIGE_CT	Location:	SW			
ADA ID: 4B65D93F5E29	Ramp T	Initial Pa	Initial Pass/Fail: Fail Overall Compliance:				o Severity Score:	8.75		
Codes/Mitigation Info/Possible Solution				Field Measurements/Component Compliance						
		Possible Solutions:	(Compl	iance Description	otion Data Co		Compliance Description		
and a set of the set		Remove & Replace Curb Ramp W Two New Directional Ramps or Equivalent.	/ith I	N/A	Ramp Length (in)	72.0	Yes	Ramp Slope (%)	6.2	
				No	Ramp Width (in)	36.0	Yes	Ramp XSlope (%)	1.9	
			1	N/A	Flare Type LT	N/A	N/A	Flare Type RT	N/A	
			1	N/A	Flare Slope LT (%)	N/A	N/A	Flare Slope RT (%)	N/A	
				N/A	Flare Traversable LT?	N/A	N/A	Flare Traversable RT?	N/A

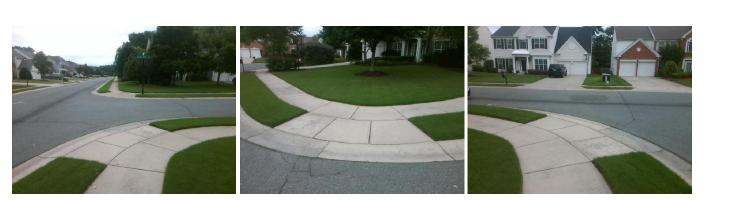
Street 2 Name	NOLAND WOODS DR		I	N/A	Ramp inside XWalk1?	N/A	N/A	Ramp inside XWalk2?	N/A	
Stop Condition-Street 1	None				Road Slope (%)	0.7	N/A	Clear Space?	N/A	
					Road X Slope (%)	3.0	N/A	Clear Space to XWalk (in)	N/A	
			I	N/A	Any Obstructions?	N/A	N/A	Storm Grate/Utility Hazard?	N/A	
		Total Cost: \$ 32	200.00		Obstruction Type			Storm Grate/Utility Type		
						N/A			N/A

Yes Surface Condition? (G/P)

Good
