Intersection ID: 8971	Main Street: FAIRMONT_ST	Cross Street: GRIER_AV	Location:	NE
ADA ID: 4B7068CC6148	Ramp Type: Perp	Initial Pass/Fail: Fail	Overall Compliance: No	Severity Score: 33.75

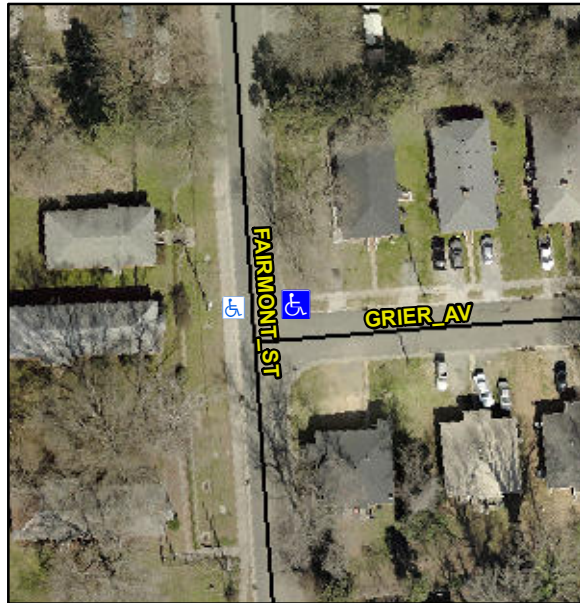
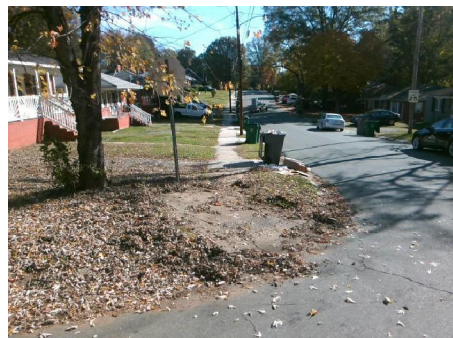
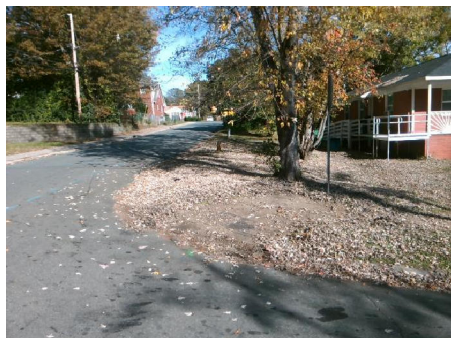
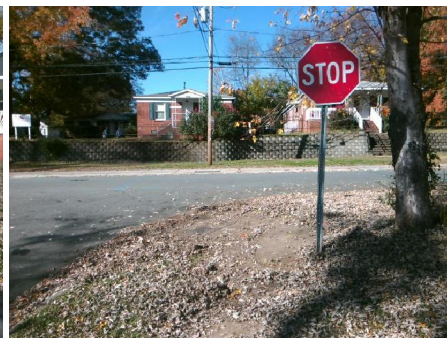
Not Found, R304.5.1, R304.5.3

Possible Solutions:			Compliance	Description	Data	Compliance	Description	Data
Remove & Replace Entire Ramp.			N/A	Ramp Length (in)	48.0	Yes	Ramp Slope (%)	6.1
			No	Ramp Width (in)	47.5	No	Ramp XSlope (%)	10.8
			N/A	Flare Type LT	N/A	N/A	Flare Type RT	N/A
			N/A	Flare Slope LT (%)	N/A	N/A	Flare Slope RT (%)	N/A
			N/A	Flare Traversable LT?	N/A	N/A	Flare Traversable RT?	N/A
			N/A	Landing Length (in)	N/A	N/A	DWS Provided?	N/A
			N/A	Landing Width (in)	N/A	N/A	DWS Contrast?	N/A
			N/A	Landing Slope (%)	N/A	N/A	DWS Length (in)	N/A
			N/A	Landing X Slope (%)	N/A	N/A	DWS Full Width?	N/A
			N/A	Landing Curb? (Y/N)	N/A	N/A	DWS Offset (in)	N/A
			N/A	Shared Landing?	N/A			
			N/A	Gutter Ponding?	N/A	N/A	Gutter Slope (%)	N/A
			N/A	Gutter Lip Ht (in)	N/A	N/A	Gutter X Slope (%)	N/A
			N/A	Painted X Walk1?	No	N/A	Painted X Walk2?	N/A
				X Walk 1 Direction	To W		X Walk 2 Direction	N/A
N/A	X Walk 1 Width (in)	N/A	N/A	X Walk 2 Width (in)	N/A

X Walk 1 Slope (%)	6.2		X Walk 2 Slope (%)	N/A			
	X Walk 1 X Slope (%)	2.7		X Walk 2 X Slope (%)	N/A			
N/A	Ramp inside XWalk1?	N/A	N/A	Ramp inside XWalk2?	N/A			
	Road Slope (%)	N/A	N/A	Clear Space?	N/A			
	Road X Slope (%)	N/A	N/A	Clear Space to XWalk (in)	N/A			
N/A	Any Obstructions?	N/A	N/A	Storm Grate/Utility Hazard?	N/A			
Total Cost:	\$	1850.00		Obstruction Type			Storm Grate/Utility Type	
					N/A			N/A
						Yes	Surface Condition? (G/P)	Good

Remove & Replace Entire Ramp.
