# Access Compliance Report

## Public Rights-of-Way

### (Curb Ramps)

Intersection ID: 11232	Main Street: BARRINGTON_DR	Cross Street: MILTON_RD	Location: SE
ADA ID: 4B7A5C26FC94	Ramp Type: PerpDiag	Initial Pass/Fail: Fail	Overall Compliance: No
		Severity Score: 22.5

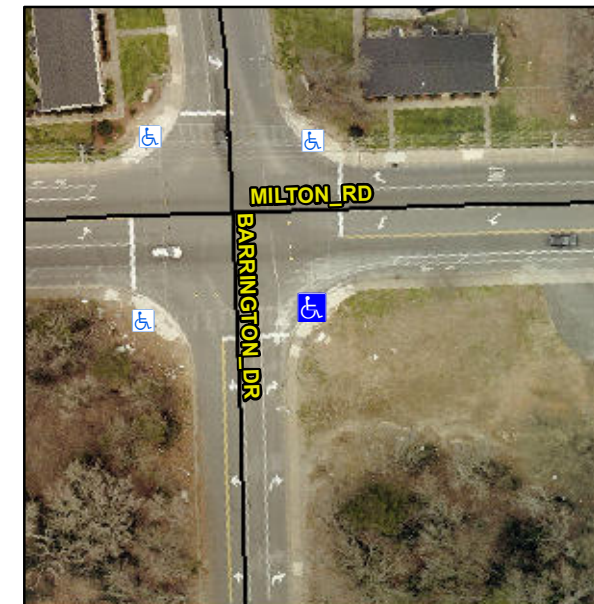
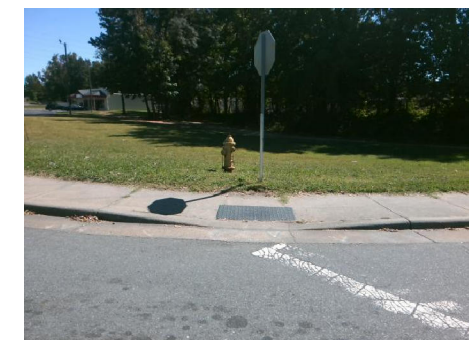
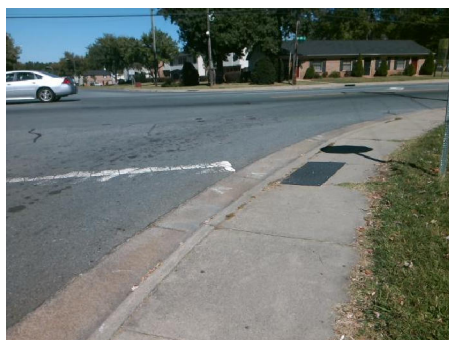
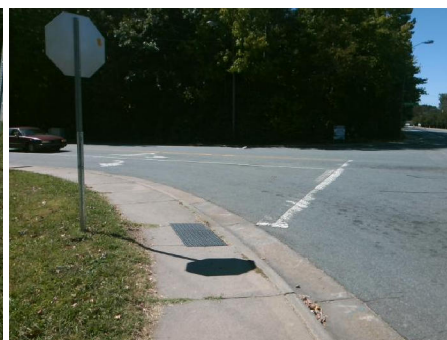
**Not Found, R304.5.1, R304.2.2, R304.5.3**

Compliance	Description	Data	Compliance	Description	Data
N/A	Ramp Length (in)	60.0	No	Ramp Slope (%)	9.6
No	Ramp Width (in)	39.5	No	Ramp XSlope (%)	3.1
N/A	Flare Type LT	N/A	N/A	Flare Type RT	N/A
N/A	Flare Slope LT (%)	N/A	N/A	Flare Slope RT (%)	N/A
N/A	Flare Traversable LT?	N/A	N/A	Flare Traversable RT?	N/A
N/A	Landing Length (in)	N/A	N/A	DWS Provided?	N/A
N/A	Landing Width (in)	N/A	N/A	DWS Contrast?	N/A
N/A	Landing Slope (%)	N/A	N/A	DWS Length (in)	N/A
N/A	Landing X Slope (%)	N/A	N/A	DWS Full Width?	N/A
N/A	Landing Curb? (Y/N)	N/A	N/A	DWS Offset (in)	N/A
N/A	Shared Landing?	N/A			
N/A	Gutter Ponding?	N/A	N/A	Gutter Slope (%)	N/A
N/A	Gutter Lip Ht (in)	N/A	N/A	Gutter X Slope (%)	N/A
N/A	Painted X Walk1?	No	N/A	Painted X Walk2?	No
	X Walk 1 Direction	To N		X Walk 2 Direction	To W
N/A	X Walk 1 Width (in)	N/A	N/A	X Walk 2 Width (in)	N/A
	X Walk 1 Slope (%)	3.9		X Walk 2 Slope (%)	0.6
	X Walk 1 X Slope (%)	0.9		X Walk 2 X Slope (%)	3.8

N/A	Ramp inside XWalk1?	N/A	N/A	Ramp inside XWalk2?	N/A
	Road Slope (%)	2.9	N/A	Clear Space?	N/A
	Road X Slope (%)	3.6	N/A	Clear Space to XWalk (in)	N/A
N/A	Any Obstructions?	N/A	N/A	Storm Grate/Utility Hazard?	N/A
	Obstruction Type			Storm Grate/Utility Type	
		N/A			N/A
			Yes	Surface Condition? (G/P)	Good

**Remove & Replace Curb Ramp With Two New Directional Ramps or Equivalent.**
