Access Compliance Report

Public Rights-of-Way

(Curb Ramps)

Intersection ID: 14217	Main Street: KENHILL_DR	Cross Street: WEST_BV	Location: NE
ADA ID: 4B8C1A5DDDE5	Ramp Type: Combination1Diag	Initial Pass/Fail: Fail	Overall Compliance: No
Severity Score: 0			
Codes/Mitigation Info/Possible Solution		Field Measurements/Component Compliance

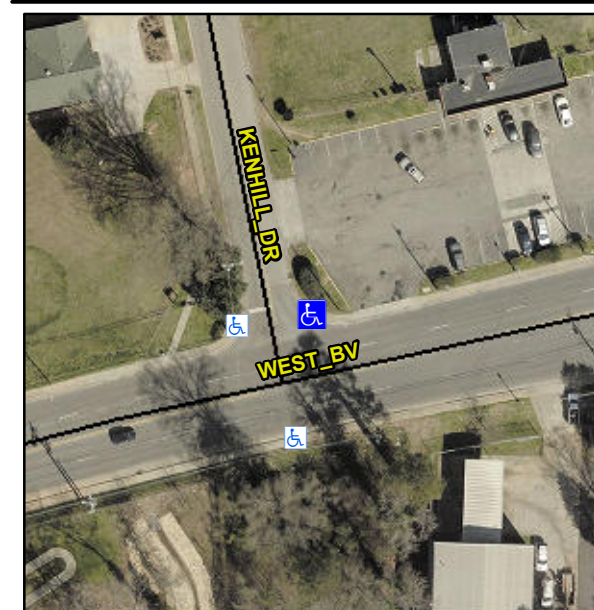
Not Found, R304.5.1, R304.5.3

Compliance	Description	Data	Compliance	Description	Data
N/A	Ramp Length LT (in)	55.0	N/A	Ramp Length RT (in)	56.0
Yes	Ramp Width LT (in)	48.0	Yes	Ramp Width RT (in)	48.0
Yes	Ramp Slope LT (%)	5.8	Yes	Ramp Slope RT (%)	6.5
No	Ramp XSlope LT (%)	6.0	No	Ramp XSlope RT (%)	5.7
N/A	Ramp Length (in)	42.0	Yes	Ramp Slope (%)	5.4
No	Ramp Width (in)	44.0	Yes	Ramp XSlope (%)	0.5
N/A	Flare Type LT	N/A	N/A	Flare Type RT	N/A
N/A	Flare Slope LT (%)	N/A	N/A	Flare Slope RT (%)	N/A
N/A	Flare Traversable LT?	N/A	N/A	Flare Traversable RT?	N/A
N/A	Landing Length (in)	N/A	N/A	DWS Provided?	N/A
N/A	Landing Width (in)	N/A	N/A	DWS Contrast?	N/A
N/A	Landing Slope (%)	N/A	N/A	DWS Length (in)	N/A
N/A	Landing X Slope (%)	N/A	N/A	DWS Full Width?	N/A
N/A	Landing Curb? (Y/N)	N/A	N/A	DWS Offset (in)	N/A
N/A	Shared Landing?	N/A			
N/A	Gutter Ponding?	N/A	N/A	Gutter Slope (%)	N/A
N/A	Gutter Lip Ht (in)	N/A	N/A	Gutter X Slope (%)	N/A
N/A	Painted X Walk1?	No	N/A	Painted X Walk2?	No

Remove & Replace Curb Ramp With Two New Directional Ramps or Equivalent.
