Access Compliance Report

Public Rights-of-Way

(Curb Ramps)

Intersection ID: N/A	Main Street: WENDOVER_CR	Cross Street: SHARON_RD	Location: SE
ADA ID: 4B9452BD85AF	Ramp Type: Perp	Initial Pass/Fail: Fail	Overall Compliance: No
Severity Score: 46.25			
Codes/Mitigation Info/Possible Solution		Field Measurements/Component Compliance

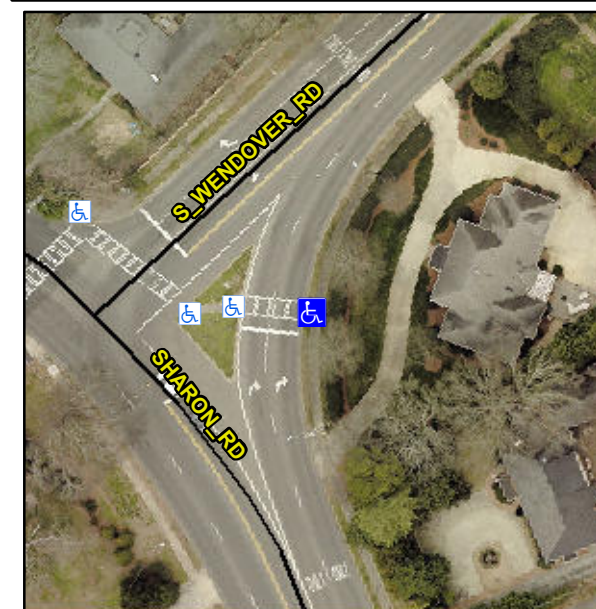
Not Found, R304.5.1, R304.2.2, R304.5.3

Compliance	Description	Data	Compliance	Description	Data
N/A	Ramp Length (in)	56.0	No	Ramp Slope (%)	14.2
No	Ramp Width (in)	38.5	No	Ramp XSlope (%)	6.1
N/A	Flare Type LT	N/A	N/A	Flare Type RT	N/A
N/A	Flare Slope LT (%)	N/A	N/A	Flare Slope RT (%)	N/A
N/A	Flare Traversable LT?	N/A	N/A	Flare Traversable RT?	N/A
N/A	Landing Length (in)	N/A	N/A	DWS Provided?	N/A
N/A	Landing Width (in)	N/A	N/A	DWS Contrast?	N/A
N/A	Landing Slope (%)	N/A	N/A	DWS Length (in)	N/A
N/A	Landing X Slope (%)	N/A	N/A	DWS Full Width?	N/A
N/A	Landing Curb? (Y/N)	N/A	N/A	DWS Offset (in)	N/A
N/A	Shared Landing?	N/A			
N/A	Gutter Ponding?	N/A	N/A	Gutter Slope (%)	N/A
N/A	Gutter Lip Ht (in)	N/A	N/A	Gutter X Slope (%)	N/A
N/A	Painted X Walk1?	Yes	N/A	Painted X Walk2?	N/A
	X Walk 1 Direction	To NW		X Walk 2 Direction	N/A
N/A	X Walk 1 Width (in)	103.0	N/A	X Walk 2 Width (in)	N/A
	X Walk 1 Slope (%)	4.9		X Walk 2 Slope (%)	N/A
	X Walk 1 X Slope (%)	4.2		X Walk 2 X Slope (%)	N/A

N/A	Ramp inside XWalk1?	Yes	N/A	Ramp inside XWalk2?	N/A
	Road Slope (%)	N/A	N/A	Clear Space?	N/A
	Road X Slope (%)	N/A	N/A	Clear Space to XWalk (in)	N/A
N/A	Any Obstructions?	N/A	N/A	Storm Grate/Utility Hazard?	N/A
	Obstruction Type			Storm Grate/Utility Type	
		N/A			N/A
			Yes	Surface Condition? (G/P)	Good

Possible Solutions:

Remove & Replace Entire Ramp.
