# Access Compliance Report

## Public Rights-of-Way

### (Curb Ramps)

Intersection ID: 11660	Main Street: E_20TH_ST	Cross Street: HARRILL_ST	Location: NW
ADA ID: 4B9788EE4862	Ramp Type: PerpDiag	Initial Pass/Fail: Fail	Overall Compliance: No
		Severity Score: 60

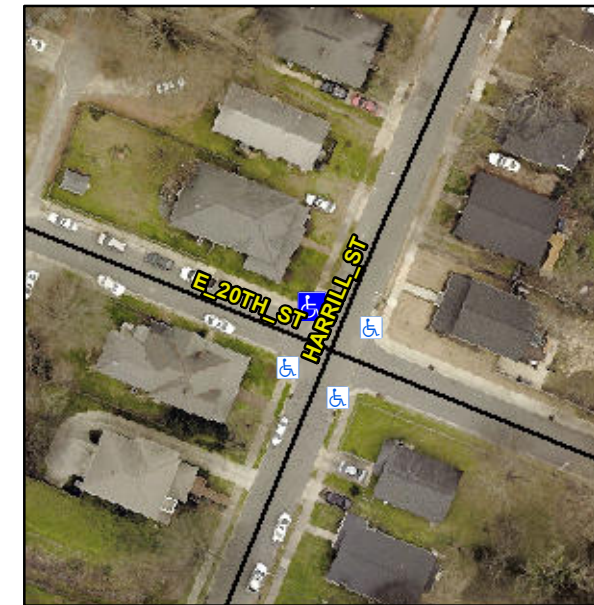
**N/A**

**Not Found, R304.5.1, R304.2.2**

Compliance	Description	Data	Compliance	Description	Data
N/A	Ramp Length (in)	56.0	No	Ramp Slope (%)	13.3
No	Ramp Width (in)	31.0	Yes	Ramp XSlope (%)	0.8
N/A	Flare Type LT	N/A	N/A	Flare Type RT	N/A
N/A	Flare Slope LT (%)	N/A	N/A	Flare Slope RT (%)	N/A
N/A	Flare Traversable LT?	N/A	N/A	Flare Traversable RT?	N/A
N/A	Landing Length (in)	N/A	N/A	DWS Provided?	N/A
N/A	Landing Width (in)	N/A	N/A	DWS Contrast?	N/A
N/A	Landing Slope (%)	N/A	N/A	DWS Length (in)	N/A
N/A	Landing X Slope (%)	N/A	N/A	DWS Full Width?	N/A
N/A	Landing Curb? (Y/N)	N/A	N/A	DWS Offset (in)	N/A
N/A	Shared Landing?	N/A			
N/A	Gutter Ponding?	N/A	N/A	Gutter Slope (%)	N/A
N/A	Gutter Lip Ht (in)	N/A	N/A	Gutter X Slope (%)	N/A
N/A	Painted X Walk1?	No	N/A	Painted X Walk2?	No
	X Walk 1 Direction	To SE		X Walk 2 Direction	To SW
N/A	X Walk 1 Width (in)	N/A	N/A	X Walk 2 Width (in)	N/A
	X Walk 1 Slope (%)	3.4		X Walk 2 Slope (%)	2.2
	X Walk 1 X Slope (%)	0.0		X Walk 2 X Slope (%)	2.9

N/A	Ramp inside XWalk1?	N/A	N/A	Ramp inside XWalk2?	N/A
	Road Slope (%)	1.2	N/A	Clear Space?	N/A
	Road X Slope (%)	3.3	N/A	Clear Space to XWalk (in)	N/A
N/A	Any Obstructions?	N/A	N/A	Storm Grate/Utility Hazard?	N/A
	Obstruction Type			Storm Grate/Utility Type	
		N/A			N/A
			Yes	Surface Condition? (G/P)	Good

**Remove & Replace Curb Ramp With Two New Directional Ramps or Equivalent.**

Total Cost: \$ 3200.00
