Access Compliance Report

Public Rights-of-Way

(Curb Ramps)

Intersection ID: 48139	Main Street: BEATY_CALDWELL_LN	Cross Street: WEDDINGTON_RD	Location: NE
ADA ID: 4B9F609C13B9	Ramp Type: BlendTrans1	Initial Pass/Fail: Fail	Overall Compliance: No
		Severity Score: 10

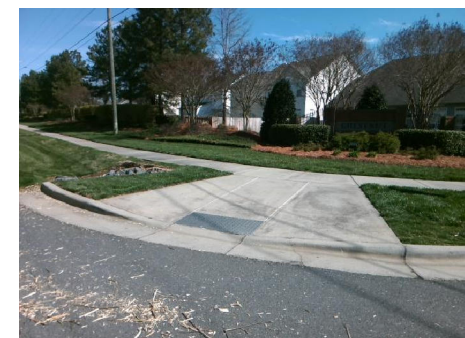
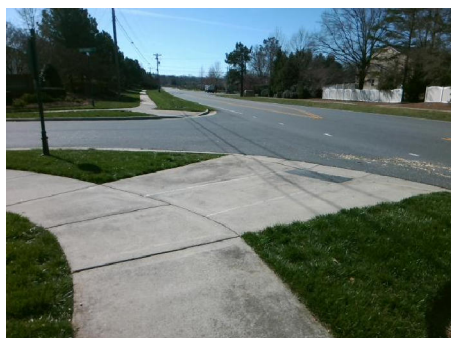
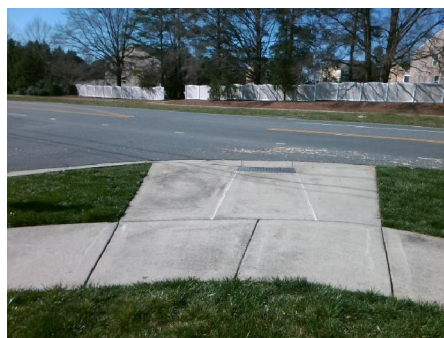
Not Found, R304.5.1, R304.5.3

Compliance	Description	Data	Compliance	Description	Data
N/A	Ramp Length (in)	145.0	Yes	BlendTrans Slope (%)	4.6
No	Ramp Width (in)	47.5	No	BlendTrans XSlope (%)	2.3
N/A	Flare Type LT	N/A	N/A	Flare Type RT	N/A
N/A	Flare Slope LT (%)	N/A	N/A	Flare Slope RT (%)	N/A
N/A	Flare Traversable LT?	N/A	N/A	Flare Traversable RT?	N/A
N/A	Landing Length (in)	N/A	N/A	DWS Provided?	N/A
N/A	Landing Width (in)	N/A	N/A	DWS Contrast?	N/A
N/A	Landing Slope (%)	N/A	N/A	DWS Length (in)	N/A
N/A	Landing X Slope (%)	N/A	N/A	DWS Full Width?	N/A
N/A	Landing Curb? (Y/N)	N/A	N/A	DWS Offset (in)	N/A
N/A	Shared Landing?	N/A			
N/A	Gutter Ponding?	N/A	N/A	Gutter Slope (%)	N/A
N/A	Gutter Lip Ht (in)	N/A	N/A	Gutter X Slope (%)	N/A
N/A	Painted X Walk1?	No	N/A	Painted X Walk2?	N/A
	X Walk 1 Direction	To S		X Walk 2 Direction	N/A
	X Walk 1 Width (in)	N/A		X Walk 2 Width (in)	N/A
	X Walk 1 Slope (%)	1.6		X Walk 2 Slope (%)	N/A
	X Walk 1 X Slope (%)	2.1		X Walk 2 X Slope (%)	N/A

N/A	Ramp inside XWalk1?	N/A	N/A	Ramp inside XWalk2?	N/A
	Road Slope (%)	2.1		Clear Space?	N/A
	Road X Slope (%)	1.6	N/A	Clear Space to XWalk (in)	N/A
N/A	Any Obstructions?	N/A	N/A	Storm Grate/Utility Hazard?	N/A
	Obstruction Type			Storm Grate/Utility Type	
		N/A			N/A
			Yes	Surface Condition? (G/P)	Good
			No	Curb Slope (%)	14.3

Remove & Replace Curb Ramp With Two New Directional Ramps or Equivalent.
