# Access Compliance Report

## Public Rights-of-Way

### (Curb Ramps)

Intersection ID: 22317	Main Street: SHARON_RD	Cross Street: SHARON_ACRES_RD	Location: NW
ADA ID: 4BAB84AEBCA5	Ramp Type: Perp	Initial Pass/Fail: Fail	Overall Compliance: No
Severity Score: 21.25			
Codes/Mitigation Info/Possible Solution		Field Measurements/Component Compliance

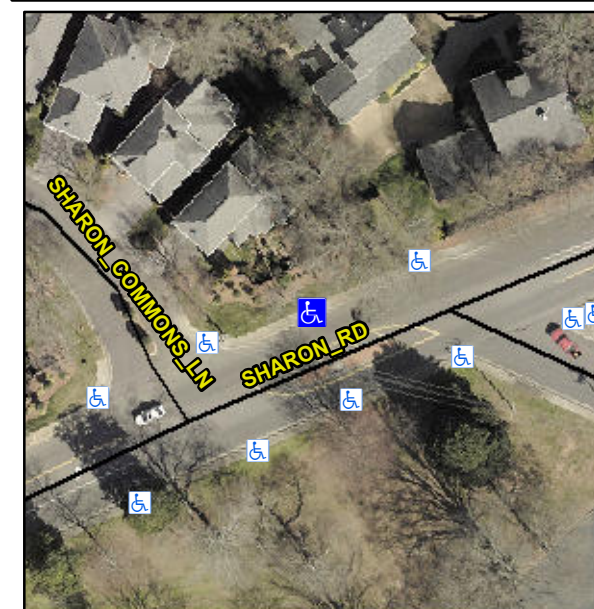
**Not Found, R304.5.1, R304.2.2**

Compliance	Description	Data	Compliance	Description	Data
N/A	Ramp Length (in)	60.0	No	Ramp Slope (%)	8.8
No	Ramp Width (in)	47.0	Yes	Ramp XSlope (%)	1.9
N/A	Flare Type LT	N/A	N/A	Flare Type RT	N/A
N/A	Flare Slope LT (%)	N/A	N/A	Flare Slope RT (%)	N/A
N/A	Flare Traversable LT?	N/A	N/A	Flare Traversable RT?	N/A
N/A	Landing Length (in)	N/A	N/A	DWS Provided?	N/A
N/A	Landing Width (in)	N/A	N/A	DWS Contrast?	N/A
N/A	Landing Slope (%)	N/A	N/A	DWS Length (in)	N/A
N/A	Landing X Slope (%)	N/A	N/A	DWS Full Width?	N/A
N/A	Landing Curb? (Y/N)	N/A	N/A	DWS Offset (in)	N/A
N/A	Shared Landing?	N/A			
N/A	Gutter Ponding?	N/A	N/A	Gutter Slope (%)	N/A
N/A	Gutter Lip Ht (in)	N/A	N/A	Gutter X Slope (%)	N/A
N/A	Painted X Walk1?	No	N/A	Painted X Walk2?	N/A
	X Walk 1 Direction	To S		X Walk 2 Direction	N/A
N/A	X Walk 1 Width (in)	N/A	N/A	X Walk 2 Width (in)	N/A
	X Walk 1 Slope (%)	5.3		X Walk 2 Slope (%)	N/A
	X Walk 1 X Slope (%)	0.5		X Walk 2 X Slope (%)	N/A

N/A	Ramp inside XWalk1?	N/A	N/A	Ramp inside XWalk2?	N/A
	Road Slope (%)	N/A	N/A	Clear Space?	N/A
	Road X Slope (%)	N/A	N/A	Clear Space to XWalk (in)	N/A
N/A	Any Obstructions?	N/A	N/A	Storm Grate/Utility Hazard?	N/A
	Obstruction Type			Storm Grate/Utility Type	
		N/A			N/A
			Yes	Surface Condition? (G/P)	Good

**Remove & Replace Entire Ramp.**

Total Cost: \$ 1850.00
