Access Compliance Report Public Rights-of-Way (Curb Ramps)

Intersection ID: 27628 Main Street: BALLANTYNE_COMMONS_PY Cross Street: ADAIR_MANOR_CT Location: N

Overall Compliance: No ADA ID: 4BB79EA3DF26 Ramp Type: Perp Initial Pass/Fail: Fail **Severity Score:** 8.75

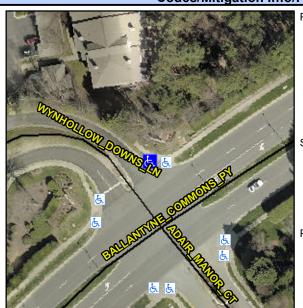
Comp	liance Description	Data	Comp	liance Description	Data
N/A	Ramp Length (in)	107.0	Yes	Ramp Slope (%)	6.9
No	Ramp Width (in)	37.0	Yes	Ramp XSlope (%)	1.3
N/A	Flare Type LT	N/A	N/A	Flare Type RT	N/A
N/A	Flare Slope LT (%)	N/A	N/A	Flare Slope RT (%)	N/A
N/A	Flare Traversable LT?	N/A	N/A	Flare Traversable RT?	N/A
N/A	Landing Length (in)	N/A	N/A	DWS Provided?	N/A
N/A	Landing Width (in)	N/A	N/A	DWS Contrast?	N/A
N/A	Landing Slope (%)	N/A	N/A	DWS Length (in)	N/A
N/A	Landing X Slope (%)	N/A	N/A	DWS Full Width?	N/A
N/A	Landing Curb? (Y/N)	N/A	N/A	DWS Offset (in)	N/A
N/A	Shared Landing?	N/A			
N/A	Gutter Ponding?	N/A	N/A	Gutter Slope (%)	N/A
N/A	Gutter Lip Ht (in)	N/A	N/A	Gutter X Slope (%)	N/A
N/A	Painted X Walk1?	No	N/A	Painted X Walk2?	N/A
	X Walk 1 Direction	To SW		X Walk 2 Direction	N/A
N/A	X Walk 1 Width (in)	N/A	N/A	X Walk 2 Width (in)	N/A
	X Walk 1 Slope (%)	0.8		X Walk 2 Slope (%)	N/A
	X Walk 1 X Slope (%)	2.8		X Walk 2 X Slope (%)	N/A

N/A	Ramp inside XWalk1?	N/A	N/A	Ramp inside XWalk2?	N/A
	Road Slope (%)	N/A	N/A	Clear Space?	N/A
	Road X Slope (%)	N/A	N/A	Clear Space to XWalk (in)	N/A
N/A	Any Obstructions?	N/A	N/A	Storm Grate/Utility Hazard?	N/A
	Obstruction Type		l	Storm Grate/Utility Type	
		N/A			N/A
			Yes	Surface Condition? (G/P)	Good

Possible Solutions:				
Remove & Replace Entire Ramp.				
	I			
	1			
	ı			
Cuminium Natari				
Surveyor Notes:				
N/A	,			
	,			
PROW/ADA:	,			
Not Found, R304.5.1	'

N/A		N/A
		N/A
		N/A
		N/A
PROW/ADA:		N/A
Not Found, R304.5.1		N/A
		N/A
		N/A
		N/A
Total Cost:	\$ 1850.00	N/A
