Access Compliance Report

Public Rights-of-Way

(Curb Ramps)

Intersection ID: 17241	Main Street: S_CANTERBURY_RD	Cross Street: S_WENDOVER_RD	Location: SW
ADA ID: 4BC79593D672	Ramp Type: Directional1	Initial Pass/Fail: Fail	Overall Compliance: No
Severity Score: 12.5			
Codes/Mitigation Info/Possible Solution		Field Measurements/Component Compliance

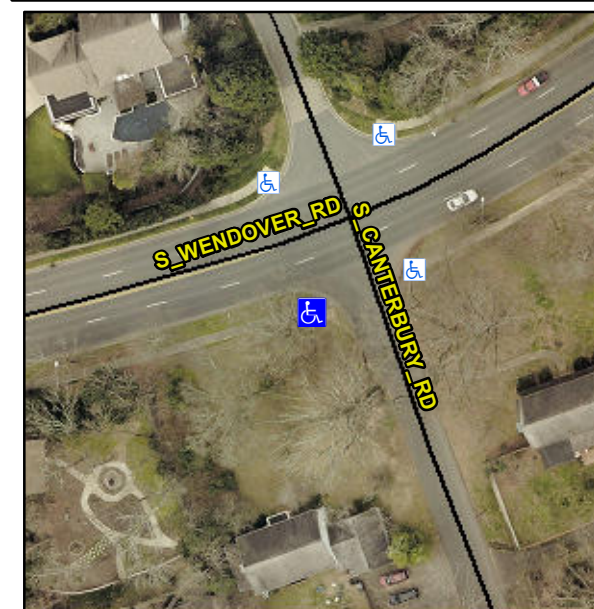
Compliance	Description	Data	Compliance	Description	Data
N/A	Ramp Length (in)	67.0	N/A	Grade Break?	N/A
Yes	Ramp Width (in)	59.0	N/A	Grade Break Slope (%)	0.0
Yes	Ramp Slope (%)	0.1	N/A	Grade Break XSlope (%)	0.0
No	Ramp XSlope (%)	5.1			
N/A	Flare Type LT	N/A	N/A	Flare Type RT	N/A
N/A	Flare Slope LT (%)	N/A	N/A	Flare Slope RT (%)	0.0
N/A	Flare Traversable LT?	N/A	N/A	Flare Traversable RT?	N/A
N/A	Landing Length (in)	0.0	N/A	DWS Provided?	N/A
N/A	Landing Width (in)	0.0	N/A	DWS Contrast?	N/A
N/A	Landing Slope (%)	0.0	N/A	DWS Length (in)	N/A
N/A	Landing X Slope (%)	0.0	N/A	DWS Full Width?	N/A
N/A	Landing Curb? (Y/N)	N/A	N/A	DWS Offset LT (in)	N/A
N/A	Shared Landing?	N/A	N/A	DWS Offset RT (in)	N/A
N/A	Gutter Ponding?	0.0	N/A	Gutter Slope (%)	N/A
N/A	Gutter Lip Ht (in)	0.0	N/A	Gutter X Slope (%)	N/A
N/A	Painted X Walk1?	No		Road Slope (%)	5.8
	X Walk 1 Direction	To NE		Road X Slope (%)	1.7
	X Walk 1 Width (in)	N/A		Clear Space?	N/A

X Walk 1 Slope (%)	5.8	N/A	Clear Space to XWalk (in)	N/A
	X Walk 1 X Slope (%)	1.7	N/A	Storm Grate/Utility Hazard?	N/A
N/A	Ramp inside XWalk1?	N/A		Storm Grate/Utility Type	
N/A	Any Obstructions?	N/A			N/A
	Obstruction Type		Yes	Surface Condition? (G/P)	Good
			N/A	Curb Slope (%)	23.2

Possible Solutions:

Remove & Replace Entire Ramp.

R304.5.3
