## **Access Compliance Report Public Rights-of-Way** (Curb Ramps)

Intersection ID: 12006 Main Street: MEREDITH AV **Cross Street: WESTERLY HILLS DR** Location: NE **Overall Compliance: No ADA ID: 4BCB198EFEDD** Ramp Type: BlendTrans2 Initial Pass/Fail: Fail **Severity Score:** 10

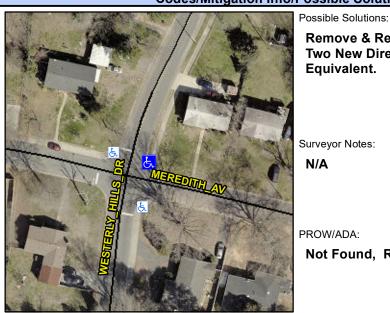
Not Found, R304.5.1, R304.5.3

Compliance Description		Data	Comp	liance Description	Data
N/A	Ramp Length (in)	99.0	Yes	BlendTrans Slope (%)	4.1
No	Ramp Width (in)	47.0	No	BlendTrans XSlope (%)	2.1
N/A	Flare Type LT	N/A	N/A	Flare Type RT	N/A
N/A	Flare Slope LT (%)	N/A	N/A	Flare Slope RT (%)	N/A
N/A	Flare Traversable LT?	N/A	N/A	Flare Traversable RT?	N/A
N/A	Landing Length (in)	N/A	N/A	DWS Provided?	N/A
N/A	Landing Width (in)	N/A	N/A	DWS Contrast?	N/A
N/A	Landing Slope (%)	N/A	N/A	DWS Length (in)	N/A
N/A	Landing X Slope (%)	N/A	N/A	DWS Full Width?	N/A
N/A	Landing Curb? (Y/N)	N/A	N/A	DWS Offset (in)	N/A
N/A	Shared Landing?	N/A			
N/A	Gutter Ponding?	N/A	N/A	Gutter Slope (%)	N/A
N/A	Gutter Lip Ht (in)	N/A	N/A	Gutter X Slope (%)	N/A
N/A	Painted X Walk1?	No	N/A	Painted X Walk2?	No
	X Walk 1 Direction	To W		X Walk 2 Direction	To S
	X Walk 1 Width (in)	N/A		X Walk 2 Width (in)	N/A
	X Walk 1 Slope (%)	4.2		X Walk 2 Slope (%)	4.4
	X Walk 1 X Slope (%)	4.5		X Walk 2 X Slope (%)	1.2

Remove & Replace Curb Ramp With Two New Directional Ramps or Equivalent.
