Access Compliance Report

Public Rights-of-Way

(Curb Ramps)

| Intersection ID: 12241 | Main Street: N_SHARON_AMITY_RD | Cross Street: SHARON_CHASE_DR | Location: W |

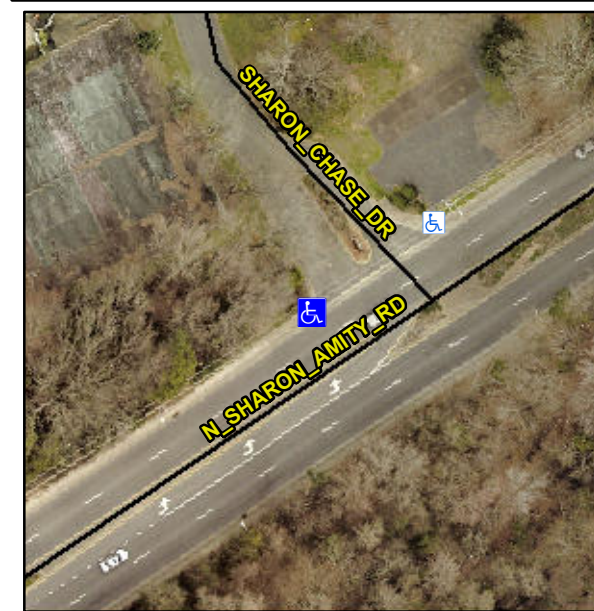
| ADA ID: 4BDB8B0564F4 | Ramp Type: Perp | Initial Pass/Fail: Fail | Overall Compliance: No |
| Severity Score: 33.75 | | | |

Not Found, R304.5.1, R304.5.3

| Compliance | Description | Data | Compliance | Description | Data |
|---|---|---|---|---|---|
| N/A | Ramp Length (in) | 60.0 | Yes | Ramp Slope (%) | 8.1 |
| No | Ramp Width (in) | 36.0 | No | Ramp XSlope (%) | 8.4 |

Possible Solutions:

Remove & Replace Entire Ramp.
