Surface Condition? (G/P)

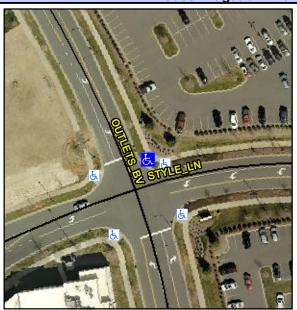
Street 1 Name	OUTLETS BV
Stop Condition-Street 2	StopSign
Street 2 Name	N/A
Stop Condition-Street 1	N/A

Possible Solutions:	Comp	Compliance Description D		Comp	liance Description
Remove & Replace Entire Ramp.	N/A	Ramp Length (in)	93.0	No	Ramp Slope (%)
	No	Ramp Width (in)	46.0	No	Ramp XSlope (%)
	N/A	Flare Type LT	N/A	N/A	Flare Type RT
C	N/A	Flare Slope LT (%)	N/A	N/A	Flare Slope RT (%)
	N/A	Flare Traversable LT?	N/A	N/A	Flare Traversable RT?
	N/A	Landing Length (in)	N/A	N/A	DWS Provided?
Surveyor Notes:	N/A	Landing Width (in)	N/A	N/A	DWS Contrast?
N/A	N/A	Landing Slope (%)	N/A	N/A	DWS Length (in)
	N/A	Landing X Slope (%)	N/A	N/A	DWS Full Width?
	N/A	Landing Curb? (Y/N)	N/A	N/A	DWS Offset (in)
	N/A	Shared Landing?	N/A		
PROW/ADA:	N/A	Gutter Ponding?	N/A	N/A	Gutter Slope (%)
Not Found, R304.5.1, R304.2.2,	N/A	Gutter Lip Ht (in)	N/A	N/A	Gutter X Slope (%)
R304.5.3	N/A	Painted X Walk1?	No	N/A	Painted X Walk2?
		X Walk 1 Direction	To W		X Walk 2 Direction
	N/A	X Walk 1 Width (in)	N/A	N/A	X Walk 2 Width (in)
		X Walk 1 Slope (%)	5.0		X Walk 2 Slope (%)
