# Access Compliance Report

## Public Rights-of-Way

### (Curb Ramps)

Intersection ID: 48999	Main Street: STEELECROFT_FARM_LN	Cross Street: STEELECROFT_PY	Location:	N
ADA ID: 4BEADF53EC96	Ramp Type: MedianPerp	Initial Pass/Fail: Fail	Overall Compliance: No	Severity Score: 12.5
Codes/Mitigation Info/Possible Solution		Field Measurements/Component Compliance

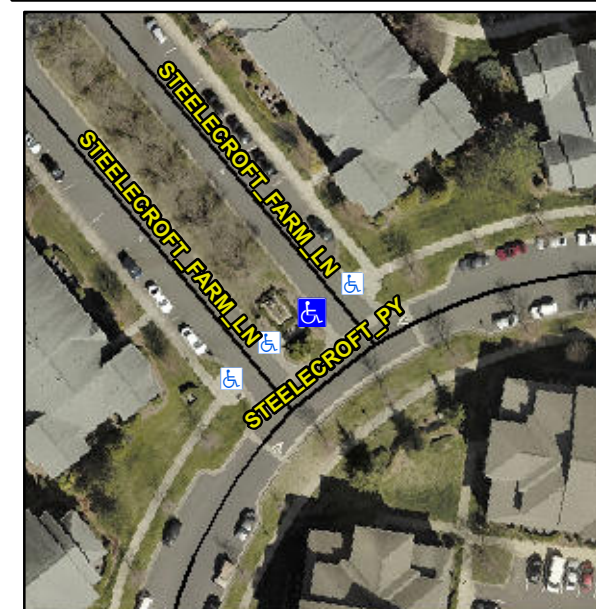
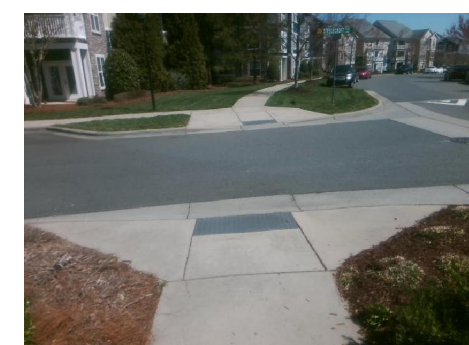
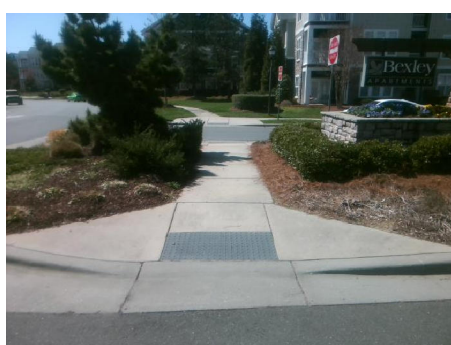
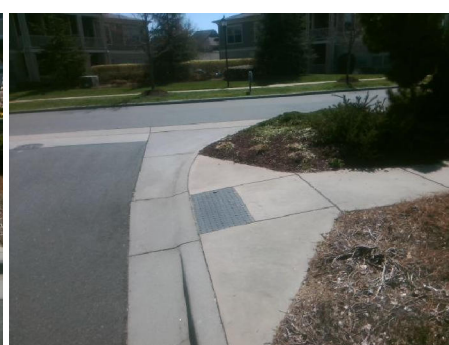
**Not Found, R304.2.2**

Compliance	Description	Data	Compliance	Description	Data
N/A	Ramp Length (in)	60.5	No	Ramp Slope (%)	9.4
Yes	Ramp Width (in)	48.5	Yes	Ramp XSlope (%)	0.9
N/A	Flare Type LT	N/A	N/A	Flare Type RT	N/A
N/A	Flare Slope LT (%)	N/A	N/A	Flare Slope RT (%)	N/A
N/A	Flare Traversable LT?	N/A	N/A	Flare Traversable RT?	N/A
N/A	Landing Length (in)	N/A	N/A	DWS Provided?	N/A
N/A	Landing Width (in)	N/A	N/A	DWS Contrast?	N/A
N/A	Landing Slope (%)	N/A	N/A	DWS Length (in)	N/A
N/A	Landing X Slope (%)	N/A	N/A	DWS Full Width?	N/A
N/A	Landing Curb? (Y/N)	N/A	N/A	DWS Offset (in)	N/A
N/A	Shared Landing?	N/A			
N/A	Gutter Ponding?	N/A	N/A	Gutter Slope (%)	N/A
N/A	Gutter Lip Ht (in)	N/A	N/A	Gutter X Slope (%)	N/A
N/A	Painted X Walk1?	No	N/A	Painted X Walk2?	N/A
	X Walk 1 Direction	To E		X Walk 2 Direction	N/A
N/A	X Walk 1 Width (in)	N/A	N/A	X Walk 2 Width (in)	N/A
	X Walk 1 Slope (%)	1.5		X Walk 2 Slope (%)	N/A
	X Walk 1 X Slope (%)	1.7		X Walk 2 X Slope (%)	N/A

N/A	Ramp inside XWalk1?	N/A	N/A	Ramp inside XWalk2?	N/A
	Road Slope (%)	N/A	N/A	Clear Space?	N/A
	Road X Slope (%)	N/A	N/A	Clear Space to XWalk (in)	N/A
N/A	Any Obstructions?	N/A	N/A	Storm Grate/Utility Hazard?	N/A
	Obstruction Type			Storm Grate/Utility Type	
		N/A			N/A
			Yes	Surface Condition? (G/P)	Good

**Remove & Replace Entire Ramp.**

Total Cost: \$ 1650.00
