Access Compliance Report

Public Rights-of-Way

(Curb Ramps)

Intersection ID: 9687	Main Street: N_PINE_ST	Cross Street: W_28TH_ST	Location: NW
ADA ID: 4BED734F90B0	Ramp Type: Perp	Initial Pass/Fail: Fail	Overall Compliance: No
		Severity Score: 25

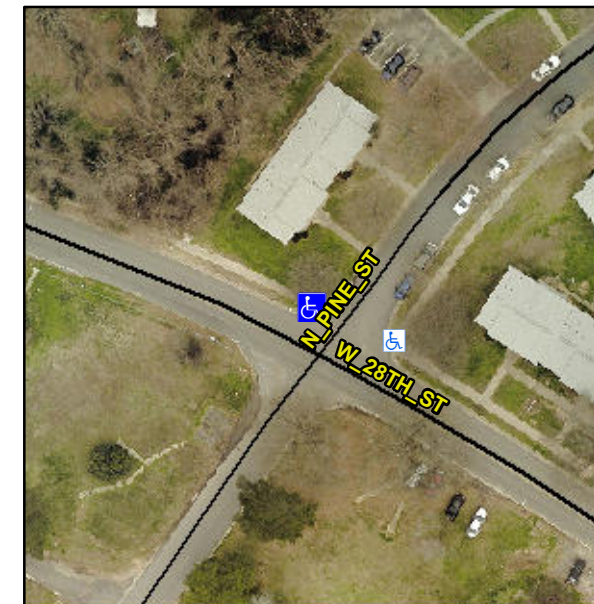
Not Found, R304.2.2

Compliance	Description	Data	Compliance	Description	Data
N/A	Ramp Length (in)	53.0	No	Ramp Slope (%)	13.8
Yes	Ramp Width (in)	49.0	Yes	Ramp XSlope (%)	1.7
N/A	Flare Type LT	N/A	N/A	Flare Type RT	N/A
N/A	Flare Slope LT (%)	N/A	N/A	Flare Slope RT (%)	N/A
N/A	Flare Traversable LT?	N/A	N/A	Flare Traversable RT?	N/A
N/A	Landing Length (in)	N/A	N/A	DWS Provided?	N/A
N/A	Landing Width (in)	N/A	N/A	DWS Contrast?	N/A
N/A	Landing Slope (%)	N/A	N/A	DWS Length (in)	N/A
N/A	Landing X Slope (%)	N/A	N/A	DWS Full Width?	N/A
N/A	Landing Curb? (Y/N)	N/A	N/A	DWS Offset (in)	N/A
N/A	Shared Landing?	N/A			
N/A	Gutter Ponding?	Yes	N/A	Gutter Slope (%)	N/A
N/A	Gutter Lip Ht (in)	0.5	N/A	Gutter X Slope (%)	N/A
N/A	Painted X Walk1?	No	N/A	Painted X Walk2?	N/A
	X Walk 1 Direction	To SE		X Walk 2 Direction	N/A
N/A	X Walk 1 Width (in)	N/A	N/A	X Walk 2 Width (in)	N/A
	X Walk 1 Slope (%)	0.8		X Walk 2 Slope (%)	N/A
	X Walk 1 X Slope (%)	0.1		X Walk 2 X Slope (%)	N/A

Remove & Replace Entire Ramp.
