Intersection ID: 20059	Main Street: BELKNAP_RD	Cross Street: FOXCROFT_RD	Location:	SE
ADA ID: 4BF09A567586	Ramp Type: PerpDiag	Initial Pass/Fail: Fail	Overall Compliance: No	Severity Score: 58.75

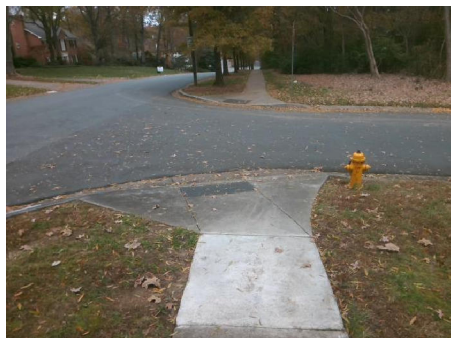
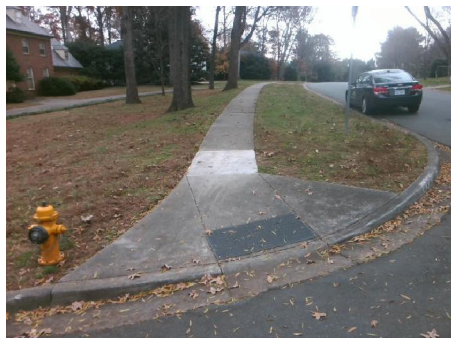
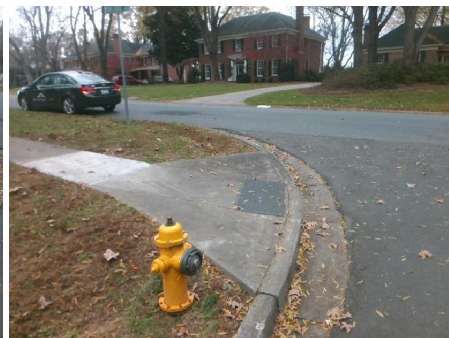
**Not Found, R304.5.1, R304.2.2,
R304.5.3**

Compliance	Description	Data	Compliance	Description	Data
N/A	Ramp Length (in)	88.0	No	Ramp Slope (%)	17.4
No	Ramp Width (in)	47.0	No	Ramp XSlope (%)	7.8
N/A	Flare Type LT	N/A	N/A	Flare Type RT	N/A
N/A	Flare Slope LT (%)	N/A	N/A	Flare Slope RT (%)	N/A
N/A	Flare Traversable LT?	N/A	N/A	Flare Traversable RT?	N/A
N/A	Landing Length (in)	N/A	N/A	DWS Provided?	N/A
N/A	Landing Width (in)	N/A	N/A	DWS Contrast?	N/A
N/A	Landing Slope (%)	N/A	N/A	DWS Length (in)	N/A
N/A	Landing X Slope (%)	N/A	N/A	DWS Full Width?	N/A
N/A	Landing Curb? (Y/N)	N/A	N/A	DWS Offset (in)	N/A
N/A	Shared Landing?	N/A			
N/A	Gutter Ponding?	N/A	N/A	Gutter Slope (%)	N/A
N/A	Gutter Lip Ht (in)	N/A	N/A	Gutter X Slope (%)	N/A
N/A	Painted X Walk1?	No	N/A	Painted X Walk2?	No
	X Walk 1 Direction	To N		X Walk 2 Direction	To W
N/A	X Walk 1 Width (in)	N/A	N/A	X Walk 2 Width (in)	N/A
	X Walk 1 Slope (%)	0.5		X Walk 2 Slope (%)	9.8
	X Walk 1 X Slope (%)	7.4		X Walk 2 X Slope (%)	0.6

N/A	Ramp inside XWalk1?	N/A	N/A	Ramp inside XWalk2?	N/A
	Road Slope (%)	8.6	N/A	Clear Space?	N/A
	Road X Slope (%)	7.3	N/A	Clear Space to XWalk (in)	N/A
N/A	Any Obstructions?	N/A	N/A	Storm Grate/Utility Hazard?	N/A
	Obstruction Type			Storm Grate/Utility Type	
		N/A			N/A
			Yes	Surface Condition? (G/P)	Good

Remove & Replace Curb Ramp With Two New Directional Ramps or Equivalent.
