Access Compliance Report

Public Rights-of-Way

(Curb Ramps)

Intersection ID: 23277	Main Street: S_TRYON_ST	Cross Street: CAROWINDS_BV	Location: SE
ADA ID: 4BF70C66D734	Ramp Type: Perp	Initial Pass/Fail: Fail	Overall Compliance: No
Codes/Mitigation Info/Possible Solution		Field Measurements/Component Compliance	
Severity Score: 8.75

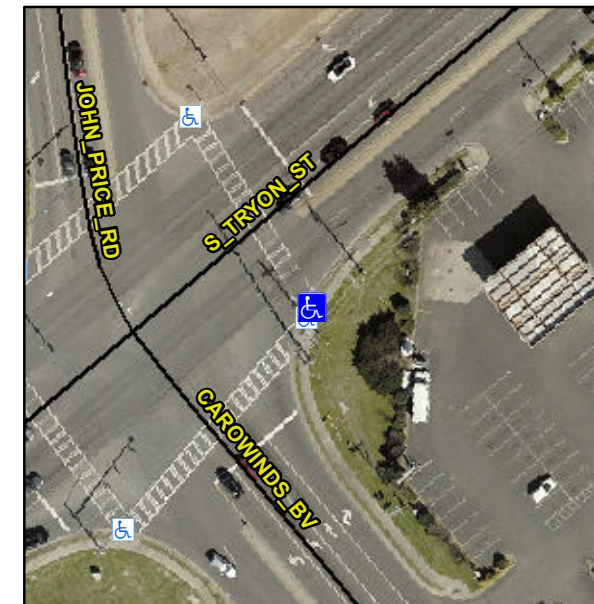
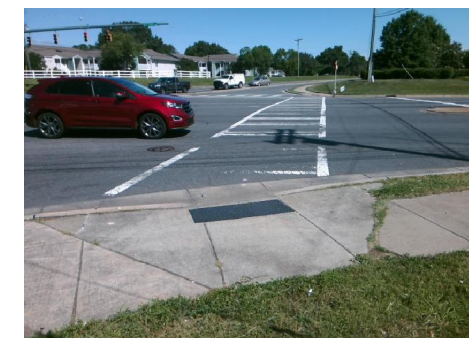
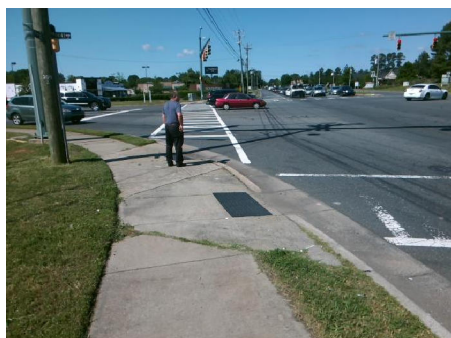
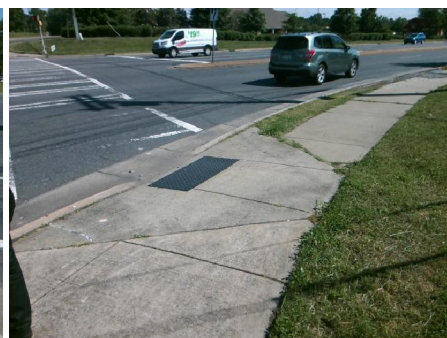
Compliance	Description	Data	Compliance	Description	Data
N/A	Ramp Length (in)	54.0	Yes	Ramp Slope (%)	7.9
No	Ramp Width (in)	45.0	Yes	Ramp XSlope (%)	0.2
N/A	Flare Type LT	N/A	N/A	Flare Type RT	N/A
N/A	Flare Slope LT (%)	N/A	N/A	Flare Slope RT (%)	N/A
N/A	Flare Traversable LT?	N/A	N/A	Flare Traversable RT?	N/A
N/A	Landing Length (in)	N/A	N/A	DWS Provided?	N/A
N/A	Landing Width (in)	N/A	N/A	DWS Contrast?	N/A
N/A	Landing Slope (%)	N/A	N/A	DWS Length (in)	N/A
N/A	Landing X Slope (%)	N/A	N/A	DWS Full Width?	N/A
N/A	Landing Curb? (Y/N)	N/A	N/A	DWS Offset (in)	N/A
N/A	Shared Landing?	N/A			
N/A	Gutter Ponding?	N/A	N/A	Gutter Slope (%)	N/A
N/A	Gutter Lip Ht (in)	N/A	N/A	Gutter X Slope (%)	N/A
N/A	Painted X Walk1?	Yes	N/A	Painted X Walk2?	N/A
	X Walk 1 Direction	To N		X Walk 2 Direction	N/A
N/A	X Walk 1 Width (in)	115.0	N/A	X Walk 2 Width (in)	N/A
	X Walk 1 Slope (%)	0.5		X Walk 2 Slope (%)	N/A
	X Walk 1 X Slope (%)	0.2		X Walk 2 X Slope (%)	N/A

N/A	Ramp inside XWalk1?	Yes	N/A	Ramp inside XWalk2?	N/A
	Road Slope (%)	N/A	N/A	Clear Space?	N/A
	Road X Slope (%)	N/A	N/A	Clear Space to XWalk (in)	N/A
N/A	Any Obstructions?	N/A	N/A	Storm Grate/Utility Hazard?	N/A
	Obstruction Type			Storm Grate/Utility Type	
		N/A			N/A
			Yes	Surface Condition? (G/P)	Good

Remove & Replace Entire Ramp.
