Access Compliance Report

Public Rights-of-Way

(Curb Ramps)

| Intersection ID: N/A | Main Street: BALLANTYNE_VILLAGE_LN | Cross Street: N/A | Location: SE |

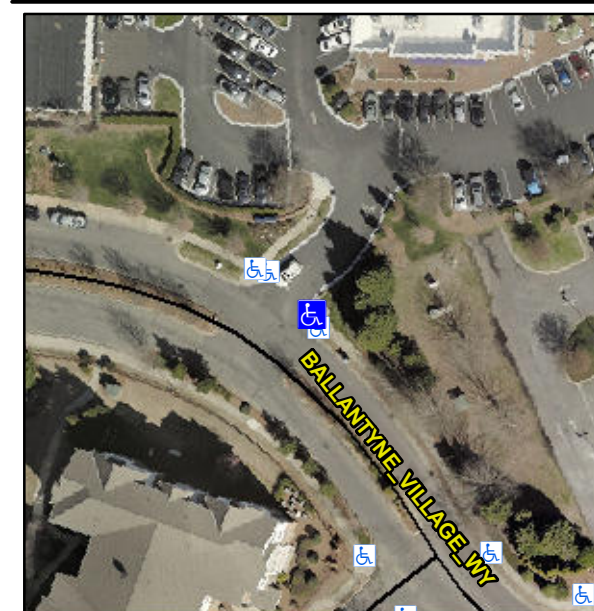
Not Found, R304.5.1, R304.2.2, R304.5.3

| Compliance | Description | Data | Compliance | Description | Data |
|---|---|---|---|---|---|
| N/A | Ramp Length (in) | 60.0 | No | Ramp Slope (%) | 9.9 |
| No | Ramp Width (in) | 46.0 | No | Ramp XSlope (%) | 8.9 |

Remove & Replace Entire Ramp.
