Access Compliance Report

Public Rights-of-Way

(Curb Ramps)

Intersection ID: 3120	Main Street: DAUPHINE_DR	Cross Street: WALDEN_RIDGE_DR	Location: S
ADA ID: 4C132AACCEA5	Ramp Type: PerpDiag	Initial Pass/Fail: Fail	Overall Compliance: No
Severity Score: 8.75			
Codes/Mitigation Info/Possible Solution		Field Measurements/Component Compliance

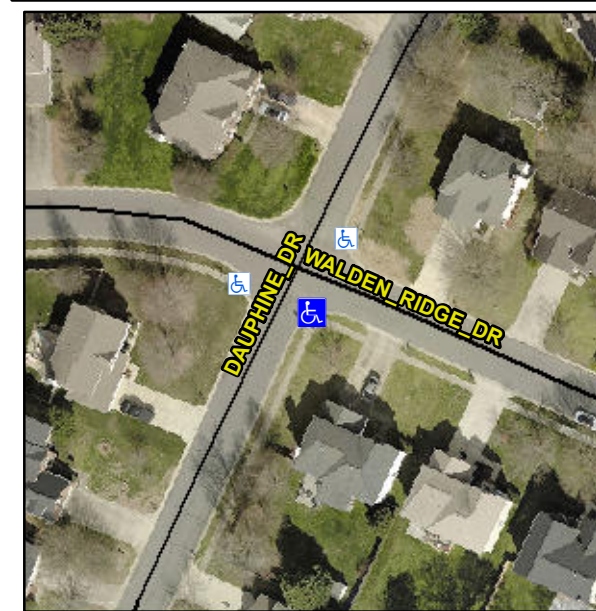
Compliance	Description	Data	Compliance	Description	Data
N/A	Ramp Length (in)	45.0	Yes	Ramp Slope (%)	7.3
No	Ramp Width (in)	45.0	Yes	Ramp XSlope (%)	1.3
N/A	Flare Type LT	N/A	N/A	Flare Type RT	N/A
N/A	Flare Slope LT (%)	N/A	N/A	Flare Slope RT (%)	N/A
N/A	Flare Traversable LT?	N/A	N/A	Flare Traversable RT?	N/A
N/A	Landing Length (in)	N/A	N/A	DWS Provided?	N/A
N/A	Landing Width (in)	N/A	N/A	DWS Contrast?	N/A
N/A	Landing Slope (%)	N/A	N/A	DWS Length (in)	N/A
N/A	Landing X Slope (%)	N/A	N/A	DWS Full Width?	N/A
N/A	Landing Curb? (Y/N)	N/A	N/A	DWS Offset (in)	N/A
N/A	Shared Landing?	N/A			
N/A	Gutter Ponding?	N/A	N/A	Gutter Slope (%)	N/A
N/A	Gutter Lip Ht (in)	N/A	N/A	Gutter X Slope (%)	N/A
N/A	Painted X Walk1?	No	N/A	Painted X Walk2?	No
	X Walk 1 Direction	To NE		X Walk 2 Direction	To NW
N/A	X Walk 1 Width (in)	N/A	N/A	X Walk 2 Width (in)	N/A
	X Walk 1 Slope (%)	2.8		X Walk 2 Slope (%)	1.8
	X Walk 1 X Slope (%)	3.8		X Walk 2 X Slope (%)	1.9

N/A	Ramp inside XWalk1?	N/A	N/A	Ramp inside XWalk2?	N/A
	Road Slope (%)	2.1	N/A	Clear Space?	N/A
	Road X Slope (%)	1.8	N/A	Clear Space to XWalk (in)	N/A
N/A	Any Obstructions?	N/A	N/A	Storm Grate/Utility Hazard?	N/A
	Obstruction Type			Storm Grate/Utility Type	
		N/A			N/A
		Yes		Surface Condition? (G/P)	Good

Possible Solutions:

Remove & Replace Curb Ramp With Two New Directional Ramps or Equivalent.

R304.5.1

Total Cost: \$ 3200.00
