# Access Compliance Report

## Public Rights-of-Way

### (Curb Ramps)

| Intersection ID: 28382 | Main Street: NEWTON_LN | Cross Street: TONAWANDA_DR | Location: N |

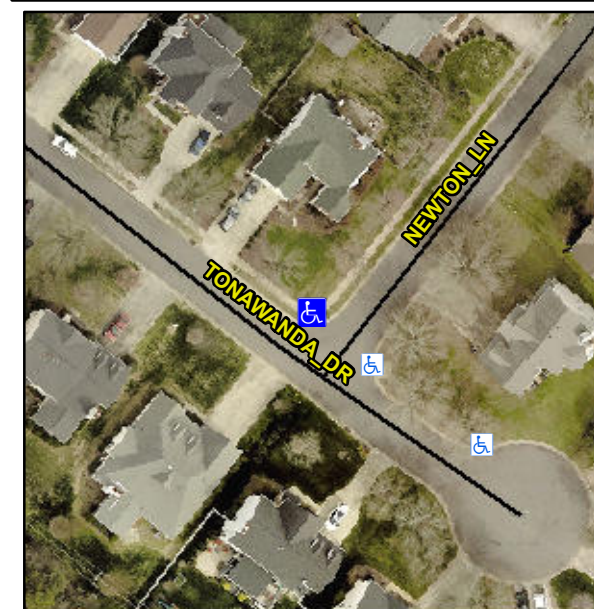
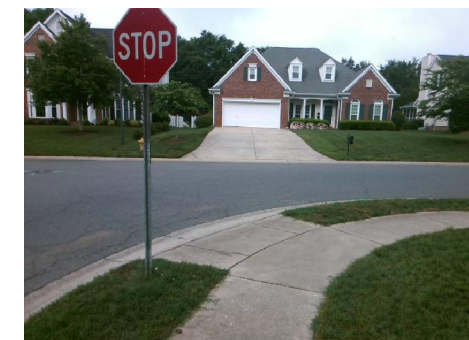
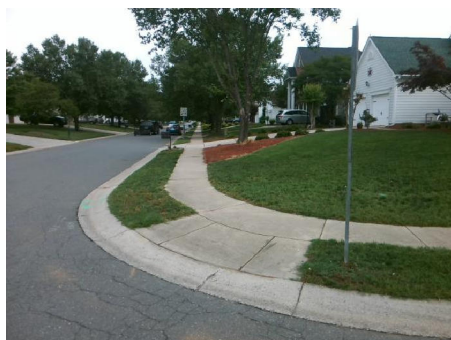
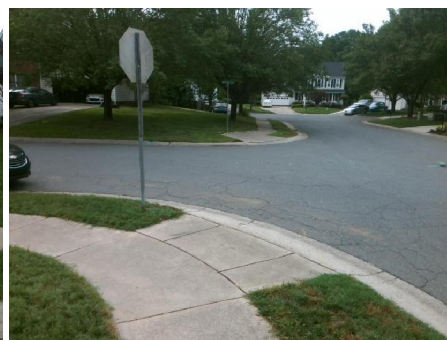
| ADA ID: 4C164A337F2F | Ramp Type: Perp | Initial Pass/Fail: Fail | Overall Compliance: No |

**Not Found, R304.5.1, R304.5.3**

| Compliance | Description | Data | Compliance | Description | Data |
|---|---|---|---|---|---|
| N/A | Ramp Length (in) | 47.0 | Yes | Ramp Slope (%) | 7.9 |
| No | Ramp Width (in) | 46.0 | No | Ramp XSlope (%) | 5.4 |

**Remove & Replace Entire Ramp.**
