Access Compliance Report Public Rights-of-Way (Curb Ramps)

Intersection ID: 3794 Main Street: DEER_CROSS_TL Cross Street: LAUREL_RIDGE_TL Location: W

ADA ID: 4C2ADB805B8F Ramp Type: Perp Initial Pass/Fail: Pass Overall Compliance: No Severity Score: 32.75

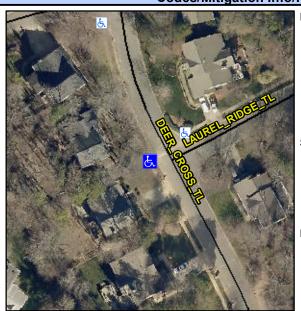
Not Found, R304.5.3, R304.2.1,
R304.2.3, R305, R302.7.2, R304.5.4

Field Measurements/Component Compliance					
Compliance Description		Data	Compliance Description		Data
N/A	Ramp Length (in)	49.0	Yes	Ramp Slope (%)	5.9
Yes	Ramp Width (in)	49.0	No	Ramp XSlope (%)	4.2
N/A	Flare Type LT	Sloped	N/A	Flare Type RT	N/A
N/A	Flare Slope LT (%)	10.5	Yes	Flare Slope RT (%)	3.0
N/A	Flare Traversable LT?	Yes	N/A	Flare Traversable RT?	Yes
No	Landing Length (in)	47.0	No	DWS Provided?	No
Yes	Landing Width (in)	48.0	N/A	DWS Contrast?	No
Yes	Landing Slope (%)	0.9	N/A	DWS Length (in)	N/A
No	Landing X Slope (%)	4.0	N/A	DWS Full Width?	No
N/A	Landing Curb? (Y/N)	No	N/A	DWS Offset (in)	N/A
N/A	Shared Landing?	No			
Yes	Gutter Ponding?	No	No	Gutter Slope (%)	6.1
No	Gutter Lip Ht (in)	1.0	Yes	Gutter X Slope (%)	3.1
N/A	Painted X Walk1?	No	N/A	Painted X Walk2?	N/A
	X Walk 1 Direction	То Е		X Walk 2 Direction	N/A
N/A	X Walk 1 Width (in)	N/A	N/A	X Walk 2 Width (in)	N/A
	X Walk 1 Slope (%)	3.5		X Walk 2 Slope (%)	N/A

X Walk 1 X Slope (%)	3.5		X Walk 2 X Slope (%)	N/A
N/A	Ramp inside XWalk1?	N/A	N/A	Ramp inside XWalk2?	N/A
	Road Slope (%)	N/A	N/A	Clear Space?	Yes
	Road X Slope (%)	N/A	N/A	Clear Space to XWalk (in)	N/A
Yes	Any Obstructions?	No	Yes	Storm Grate/Utility Hazard?	No
	Obstruction Type			Storm Grate/Utility Type	
		N/A			N/A
			Yes	Surface Condition? (G/P)	Good
				Carraco Corrantorii. (Cri	0000

Remove & Replace Entire Ramp.
Remove & Replace Gutter.
