Access Compliance Report

Public Rights-of-Way

(Curb Ramps)

Intersection ID: 51074	Main Street: HEATHCOTT_CR	Cross Street: SILVER_GLEN_LN	Location: SE
ADA ID: 4C318C45C495	Ramp Type: PerpDiag	Initial Pass/Fail: Fail	Overall Compliance: No
Codes/Mitigation Info/Possible Solution			Severity Score: 35
			Field Measurements/Component Compliance

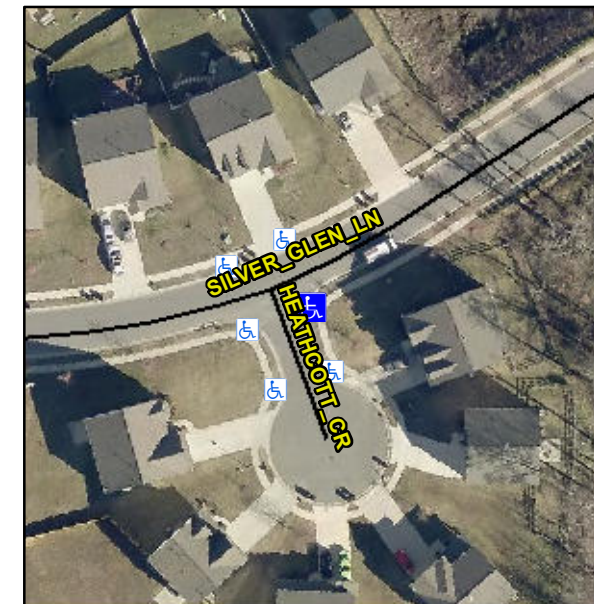
Compliance	Description	Data	Compliance	Description	Data
N/A	Ramp Length (in)	52.0	No	Ramp Slope (%)	15.6
No	Ramp Width (in)	47.5	No	Ramp XSlope (%)	3.7
N/A	Flare Type LT	N/A	N/A	Flare Type RT	N/A
N/A	Flare Slope LT (%)	N/A	N/A	Flare Slope RT (%)	N/A
N/A	Flare Traversable LT?	N/A	N/A	Flare Traversable RT?	N/A
N/A	Landing Length (in)	N/A	N/A	DWS Provided?	N/A
N/A	Landing Width (in)	N/A	N/A	DWS Contrast?	N/A
N/A	Landing Slope (%)	N/A	N/A	DWS Length (in)	N/A
N/A	Landing X Slope (%)	N/A	N/A	DWS Full Width?	N/A
N/A	Landing Curb? (Y/N)	N/A	N/A	DWS Offset (in)	N/A
N/A	Shared Landing?	N/A			
N/A	Gutter Ponding?	N/A	N/A	Gutter Slope (%)	N/A
N/A	Gutter Lip Ht (in)	1.0	N/A	Gutter X Slope (%)	N/A
N/A	Painted X Walk1?	No	N/A	Painted X Walk2?	No
	X Walk 1 Direction	To N		X Walk 2 Direction	To W
N/A	X Walk 1 Width (in)	N/A	N/A	X Walk 2 Width (in)	N/A
	X Walk 1 Slope (%)	1.7		X Walk 2 Slope (%)	3.1
	X Walk 1 X Slope (%)	3.3		X Walk 2 X Slope (%)	1.1

N/A	Ramp inside XWalk1?	N/A	N/A	Ramp inside XWalk2?	N/A
	Road Slope (%)	2.7	N/A	Clear Space?	N/A
	Road X Slope (%)	1.5	N/A	Clear Space to XWalk (in)	N/A
N/A	Any Obstructions?	N/A	N/A	Storm Grate/Utility Hazard?	N/A
	Obstruction Type			Storm Grate/Utility Type	
		N/A			N/A
			Yes	Surface Condition? (G/P)	Good

Remove & Replace Curb Ramp With Two New Directional Ramps or Equivalent.
