# Access Compliance Report

## Public Rights-of-Way

### (Curb Ramps)

Intersection ID: 19165	Main Street: BEARMORE_DR	Cross Street: ROCKY_FALLS_RD	Location: NW
ADA ID: 4C35F832F289	Ramp Type: Perp	Initial Pass/Fail: Fail	Overall Compliance: No Severity Score: 21.25

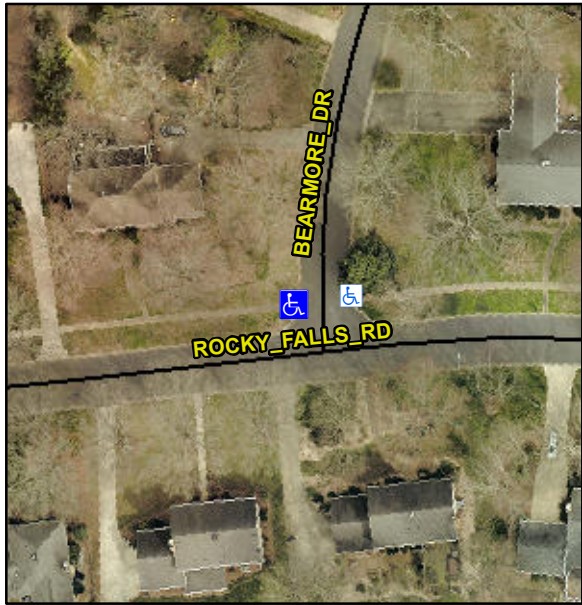
Possible Solutions:		Compliance	Description	Data	Compliance	Description	Data
	Remove & Replace Entire Ramp.		N/A	Ramp Length (in)	74.0	No	Ramp Slope (%)	9.9
			No	Ramp Width (in)	47.0	Yes	Ramp XSlope (%)	1.9
			N/A	Flare Type LT	N/A	N/A	Flare Type RT	N/A
			N/A	Flare Slope LT (%)	N/A	N/A	Flare Slope RT (%)	N/A
			N/A	Flare Traversable LT?	N/A	N/A	Flare Traversable RT?	N/A
			N/A	Landing Length (in)	N/A	N/A	DWS Provided?	N/A
			N/A	Landing Width (in)	N/A	N/A	DWS Contrast?	N/A
			N/A	Landing Slope (%)	N/A	N/A	DWS Length (in)	N/A
			N/A	Landing X Slope (%)	N/A	N/A	DWS Full Width?	N/A
Surveyor Notes:			N/A	Landing Curb? (Y/N)	N/A	N/A	DWS Offset (in)	N/A
N/A			N/A	Shared Landing?	N/A			
PROW/ADA:			N/A	Gutter Ponding?	N/A	N/A	Gutter Slope (%)	N/A
Not Found, R304.5.1, R304.2.2			N/A	Gutter Lip Ht (in)	N/A	N/A	Gutter X Slope (%)	N/A

N/A	Painted X Walk1?	No	N/A	Painted X Walk2?	N/A
				X Walk 1 Direction	To E		X Walk 2 Direction	N/A
			N/A	X Walk 1 Width (in)	N/A	N/A	X Walk 2 Width (in)	N/A
				X Walk 1 Slope (%)	2.6		X Walk 2 Slope (%)	N/A
				X Walk 1 X Slope (%)	2.9		X Walk 2 X Slope (%)	N/A
			N/A	Ramp inside XWalk1?	N/A	N/A	Ramp inside XWalk2?	N/A
				Road Slope (%)	N/A	N/A	Clear Space?	N/A
				Road X Slope (%)	N/A	N/A	Clear Space to XWalk (in)	N/A
			N/A	Any Obstructions?	N/A	N/A	Storm Grate/Utility Hazard?	N/A
				Obstruction Type			Storm Grate/Utility Type	
					N/A			N/A
						Yes	Surface Condition? (G/P)	Good
