Intersection ID: N/A	Main Street: HARRIS_OAKS_BV	Cross Street: N/A	Location:	NW
ADA ID: 4C3FFD60DC8D	Ramp Type: PerpDiag	Initial Pass/Fail: Fail	Overall Compliance: No	Severity Score: 8.75

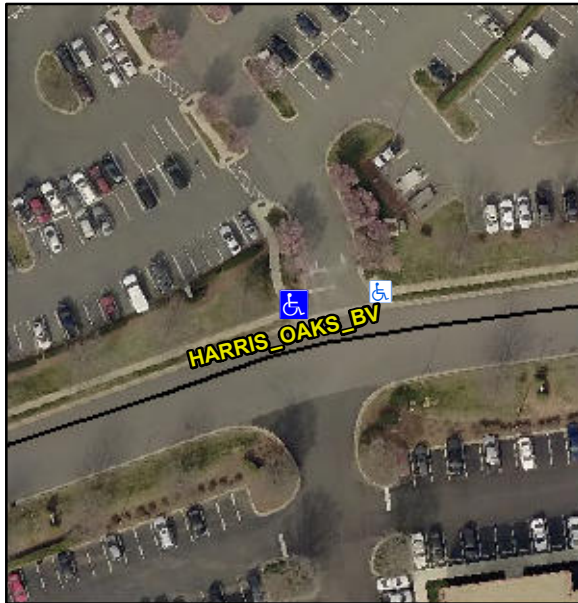
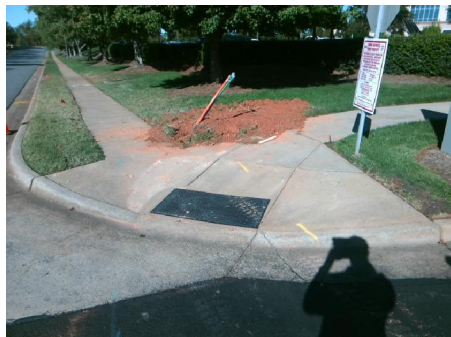
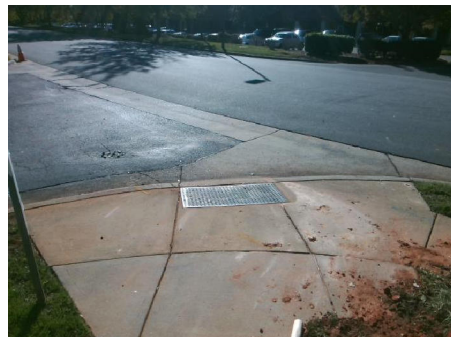
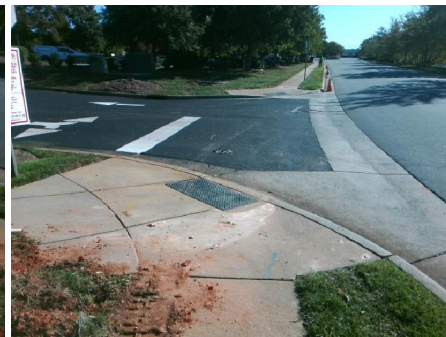
Not Found, R304.5.1

Compliance	Description	Data	Compliance	Description	Data
N/A	Ramp Length (in)	68.0	Yes	Ramp Slope (%)	7.2
No	Ramp Width (in)	46.0	Yes	Ramp XSlope (%)	1.9
N/A	Flare Type LT	N/A	N/A	Flare Type RT	N/A
N/A	Flare Slope LT (%)	N/A	N/A	Flare Slope RT (%)	N/A
N/A	Flare Traversable LT?	N/A	N/A	Flare Traversable RT?	N/A
N/A	Landing Length (in)	N/A	N/A	DWS Provided?	N/A
N/A	Landing Width (in)	N/A	N/A	DWS Contrast?	N/A
N/A	Landing Slope (%)	N/A	N/A	DWS Length (in)	N/A
N/A	Landing X Slope (%)	N/A	N/A	DWS Full Width?	N/A
N/A	Landing Curb? (Y/N)	N/A	N/A	DWS Offset (in)	N/A
N/A	Shared Landing?	N/A			
N/A	Gutter Ponding?	N/A	N/A	Gutter Slope (%)	N/A
N/A	Gutter Lip Ht (in)	N/A	N/A	Gutter X Slope (%)	N/A
N/A	Painted X Walk1?	No	N/A	Painted X Walk2?	No
	X Walk 1 Direction	To E		X Walk 2 Direction	To S
N/A	X Walk 1 Width (in)	N/A	N/A	X Walk 2 Width (in)	N/A
	X Walk 1 Slope (%)	1.4		X Walk 2 Slope (%)	2.9
	X Walk 1 X Slope (%)	1.9		X Walk 2 X Slope (%)	0.6

N/A	Ramp inside XWalk1?	N/A	N/A	Ramp inside XWalk2?	N/A
	Road Slope (%)	0.9	N/A	Clear Space?	N/A
	Road X Slope (%)	2.5	N/A	Clear Space to XWalk (in)	N/A
N/A	Any Obstructions?	N/A	N/A	Storm Grate/Utility Hazard?	N/A
	Obstruction Type			Storm Grate/Utility Type	
		N/A			N/A
			Yes	Surface Condition? (G/P)	Good

Remove & Replace Curb Ramp With Two New Directional Ramps or Equivalent.

Total Cost: \$ 3200.00
