Access Compliance Report Public Rights-of-Way (Curb Ramps)

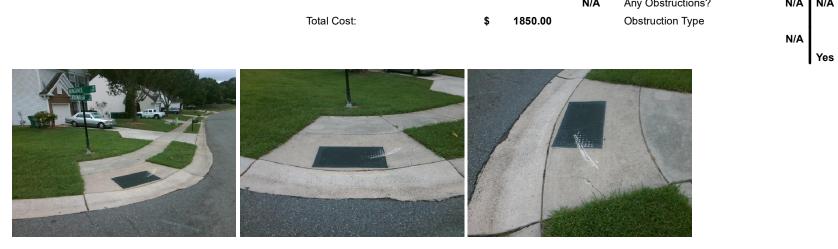
Intersection ID: 6784 Main Street: ROUNDLEAF DR				Ctro of				Leastion	05
Intersection ID: 6784 Main Street		reet: ROUNDLEAF_DR	Cross	Cross Street: WINGDALE_DR				Location:	SE
ADA ID: 4C4CBEB6F019 Ramp Type: Perp		Initial	Initial Pass/Fail: Fail Overall Compliance: No				o Severity Score:	25	
Codes/Mitigation Info/Possible Solution				Field Measurements/Component Compliance					
	A Constant	Possible Solutions:		Compliance Description D			ata Compliance Description		Data
	it and the second	Remove & Replace Entire Ram	ip.	N/A	Ramp Length (in)	48.0	No	Ramp Slope (%)	9.4

•	Yes	Ramp Width (in)	48.0	No	Ramp XSlope (%)	5.1
and an enter and the second	THE A LE			N/A	Flare Type LT	N/A	N/A	Flare Type RT	N/A
	1. 78			N/A	Flare Slope LT (%)	N/A	N/A	Flare Slope RT (%)	N/A
				N/A	Flare Traversable LT?	N/A	N/A	Flare Traversable RT?	N/A
	EDALLE DR			N/A	Landing Length (in)	N/A	N/A	DWS Provided?	N/A
		Surveyor Notes:		N/A	Landing Width (in)	N/A	N/A	DWS Contrast?	N/A
		N/A		N/A	Landing Slope (%)	N/A	N/A	DWS Length (in)	N/A
				N/A	Landing X Slope (%)	N/A	N/A	DWS Full Width?	N/A
	1 6 8 4 E			N/A	Landing Curb? (Y/N)	N/A	N/A	DWS Offset (in)	N/A
				N/A	Shared Landing?	N/A			
	in the start of	PROW/ADA:		N/A	Gutter Ponding?	N/A	N/A	Gutter Slope (%)	N/A
	A CONT	Not Found, R304.2.2, R304.5.3		N/A	Gutter Lip Ht (in)	N/A	N/A	Gutter X Slope (%)	N/A
	A start			N/A	Painted X Walk1?	No	N/A	Painted X Walk2?	N/A
					X Walk 1 Direction	To N		X Walk 2 Direction	N/A
				N/A	X Walk 1 Width (in)	N/A	N/A	X Walk 2 Width (in)	N/A

Street 1 Name	WINGDALE DR				X Walk 1 Slope (%)	9.2		X Walk 2 Slope (%)	N/A
Stop Condition-Street 2	StopSign				X Walk 1 X Slope (%)	3.5		X Walk 2 X Slope (%)	N/A
Street 2 Name	N/A			N/A	Ramp inside XWalk1?	N/A	N/A	Ramp inside XWalk2?	N/A
Stop Condition-Street 1	N/A				Road Slope (%)	N/A	N/A	Clear Space?	N/A
					Road X Slope (%)	N/A	N/A	Clear Space to XWalk (in)	N/A
				N/A	Any Obstructions?	N/A	N/A	Storm Grate/Utility Hazard?	N/A
		Total Cost: \$	1850.00		Obstruction Type			Storm Grate/Utility Type	
						N/A			N/A
