Access Compliance Report

Public Rights-of-Way

(Curb Ramps)

Intersection ID: 8685	Main Street: BEATTIES_FORD_RD	Cross Street: ST_JOHN_ST	Location: NE
ADA ID: 4C5073C17E83	Ramp Type: Perp	Initial Pass/Fail: Fail	Overall Compliance: No
		Severity Score: 25

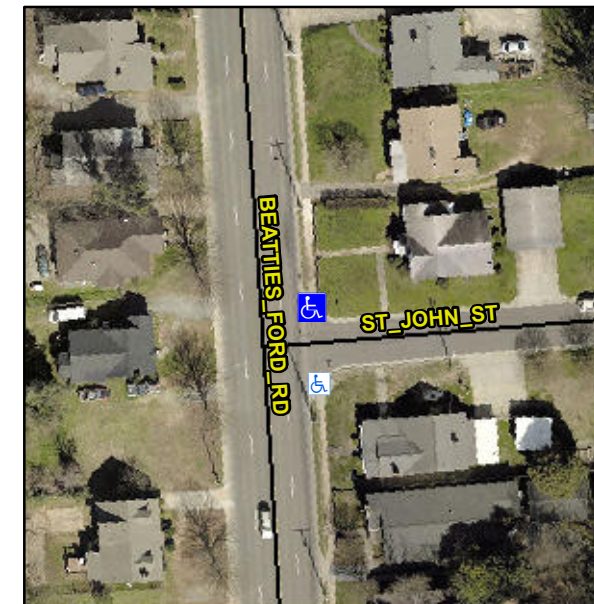
Not Found, R304.2.2, R304.5.3

Compliance	Description	Data	Compliance	Description	Data
N/A	Ramp Length (in)	27.0	No	Ramp Slope (%)	8.4
Yes	Ramp Width (in)	48.0	No	Ramp XSlope (%)	6.6
N/A	Flare Type LT	N/A	N/A	Flare Type RT	N/A
N/A	Flare Slope LT (%)	N/A	N/A	Flare Slope RT (%)	N/A
N/A	Flare Traversable LT?	N/A	N/A	Flare Traversable RT?	N/A
N/A	Landing Length (in)	N/A	N/A	DWS Provided?	N/A
N/A	Landing Width (in)	N/A	N/A	DWS Contrast?	N/A
N/A	Landing Slope (%)	N/A	N/A	DWS Length (in)	N/A
N/A	Landing X Slope (%)	N/A	N/A	DWS Full Width?	N/A
N/A	Landing Curb? (Y/N)	N/A	N/A	DWS Offset (in)	N/A
N/A	Shared Landing?	N/A			
N/A	Gutter Ponding?	N/A	N/A	Gutter Slope (%)	N/A
N/A	Gutter Lip Ht (in)	N/A	N/A	Gutter X Slope (%)	N/A
N/A	Painted X Walk1?	No	N/A	Painted X Walk2?	N/A
	X Walk 1 Direction	To S		X Walk 2 Direction	N/A
N/A	X Walk 1 Width (in)	N/A	N/A	X Walk 2 Width (in)	N/A
	X Walk 1 Slope (%)	0.2		X Walk 2 Slope (%)	N/A
	X Walk 1 X Slope (%)	7.3		X Walk 2 X Slope (%)	N/A

Remove & Replace Entire Ramp.
