Access Compliance Report

Public Rights-of-Way

(Curb Ramps)

Intersection ID: 10664	Main Street: CHARLES_AV	Cross Street: CLEMSON_AV	Location: SE
ADA ID: 4C5B1D5A0B85	Ramp Type: Perp	Initial Pass/Fail: Fail	Overall Compliance: No
		Severity Score: 50

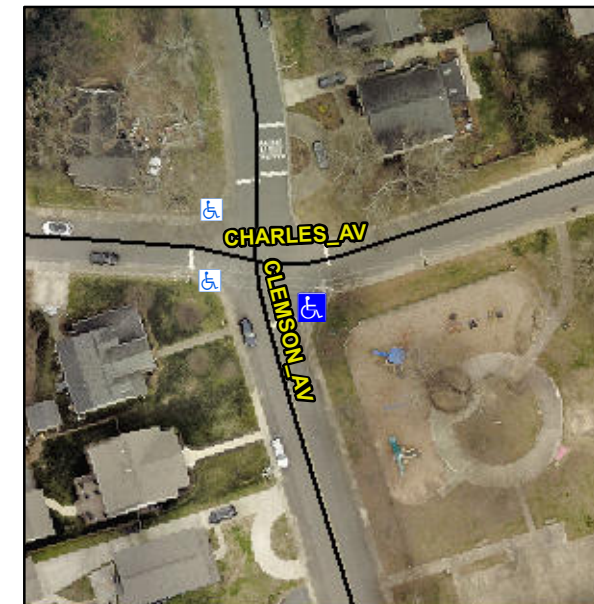
Not Found, R304.2.2, R304.5.3

Compliance	Description	Data	Compliance	Description	Data
N/A	Ramp Length (in)	72.0	No	Ramp Slope (%)	12.1
Yes	Ramp Width (in)	48.0	No	Ramp XSlope (%)	7.2
N/A	Flare Type LT	N/A	N/A	Flare Type RT	N/A
N/A	Flare Slope LT (%)	N/A	N/A	Flare Slope RT (%)	N/A
N/A	Flare Traversable LT?	N/A	N/A	Flare Traversable RT?	N/A
N/A	Landing Length (in)	N/A	N/A	DWS Provided?	N/A
N/A	Landing Width (in)	N/A	N/A	DWS Contrast?	N/A
N/A	Landing Slope (%)	N/A	N/A	DWS Length (in)	N/A
N/A	Landing X Slope (%)	N/A	N/A	DWS Full Width?	N/A
N/A	Landing Curb? (Y/N)	N/A	N/A	DWS Offset (in)	N/A
N/A	Shared Landing?	N/A			
N/A	Gutter Ponding?	N/A	N/A	Gutter Slope (%)	N/A
N/A	Gutter Lip Ht (in)	N/A	N/A	Gutter X Slope (%)	N/A
N/A	Painted X Walk1?	No	N/A	Painted X Walk2?	N/A
	X Walk 1 Direction	To NW		X Walk 2 Direction	N/A
N/A	X Walk 1 Width (in)	N/A	N/A	X Walk 2 Width (in)	N/A
	X Walk 1 Slope (%)	0.3		X Walk 2 Slope (%)	N/A
	X Walk 1 X Slope (%)	3.2		X Walk 2 X Slope (%)	N/A

Remove & Replace Entire Ramp.
