## Access Compliance Report Public Rights-of-Way (Curb Ramps)

Intersection ID: 9251 Main Street: MORETZ\_AV Cross Street: OLANDO\_ST Location: W

ADA ID: 4C6F6C99C37A Ramp Type: Para Initial Pass/Fail: Fail Overall Compliance: No Severity Score: 1.25

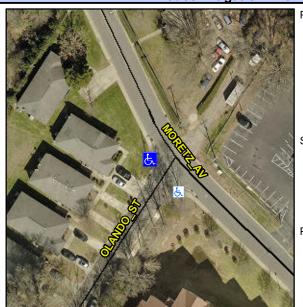
N//
N//
Surveyor Notes:

RT RP < 5%

Compliance Description Data		Compliance Description		Data	
N/A	Ramp Length LT (in)	60.5	N/A	Ramp Length RT (in)	56.0
Yes	Ramp Width LT (in)	58.5	Yes	Ramp Width RT (in)	60.5
Yes	Ramp Slope LT (%)	6.9	Yes	Ramp Slope RT (%)	4.0
No	Ramp XSlope LT (%)	2.4	No	Ramp XSlope RT (%)	2.5
N/A	Landing Length (in)	N/A	N/A	DWS Provided?	N/A
N/A	Landing Width (in)	N/A	N/A	DWS Contrast?	N/A
N/A	Landing Slope (%)	N/A	N/A	DWS Length (in)	N/A
N/A	Landing X Slope (%)	N/A	N/A	DWS Full Width?	N/A
N/A	Landing Curb? (Y/N)	N/A	N/A	DWS Offset (in)	N/A
N/A	Shared Landing?	N/A			
N/A	Gutter Ponding?	N/A	N/A	Gutter Slope (%)	N/A
N/A	Gutter Lip Ht (in)	N/A	N/A	Gutter X Slope (%)	N/A
N/A	Painted X Walk1?	No	N/A	Painted X Walk2?	N/A
	X Walk 1 Direction	To SE		X Walk 2 Direction	N/A
N/A	X Walk 1 Width (in)	N/A	N/A	X Walk 2 Width (in)	N/A
	X Walk 1 Slope (%)	4.6		X Walk 2 Slope (%)	N/A
	X Walk 1 X Slope (%)	0.2		X Walk 2 X Slope (%)	N/A
N/A	Ramp inside XWalk1?	N/A	N/A	Ramp inside XWalk2?	N/A

Road Slope (%)	N/A	N/A	Clear Space?	N/A
	Road X Slope (%)	N/A	N/A	Clear Space to XWalk (in)	N/A
N/A	Any Obstructions?	N/A	N/A	Storm Grate/Utility Hazard?	N/A
	Obstruction Type			Storm Grate/Utility Type	
		N/A			N/A
			Yes	Surface Condition? (G/P)	Good
			N/A	Curb Slope (%)	13.6

Possible Solutions:

Remove & Replace Entire Ramp.

R304.5.3
