# Access Compliance Report

## Public Rights-of-Way

| Intersection ID: 16392 | Main Street: QUEENS_RD_WEST | Cross Street: WELLESLEY_AV | Location: NW |
| ADA ID: 4C777D182FDA | Ramp Type: BlendTrans2 | Initial Pass/Fail: Fail | Overall Compliance: No |

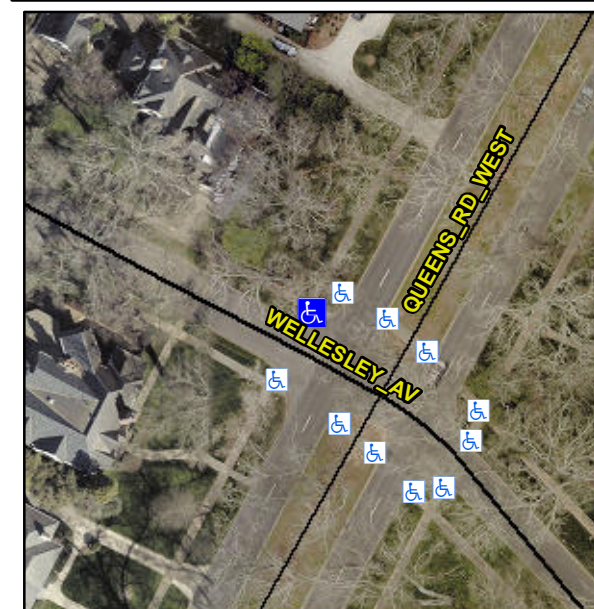
| Severity Score: 1.25 | | | |

**Not Found, R304.5.3**

| Compliance | Description | Data | Compliance | Description | Data |
|---|---|---|---|---|---|
| Yes | Ramp Width (in) | 74.0 | No | BlendTrans XSlope (%) | 4.1 |
| | | | No | Curb Slope (%) | 6.5 |

**Remove & Replace Curb Ramp With Two New Directional Ramps or Equivalent.**

Total Cost: \$ 3200.00
