Access Compliance Report

Public Rights-of-Way

(Curb Ramps)

Intersection ID: 8503	Main Street: TIMEPLANNER_DR	Cross Street: ATANDO_AV	Location: NW
ADA ID: 4C807D24B87F	Ramp Type: Perp	Initial Pass/Fail: Fail	Overall Compliance: No
Codes/Mitigation Info/Possible Solution			Severity Score: 35
			Field Measurements/Component Compliance

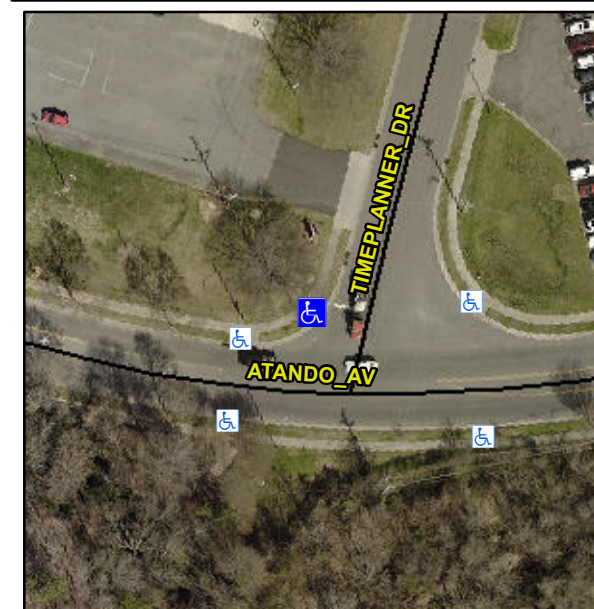
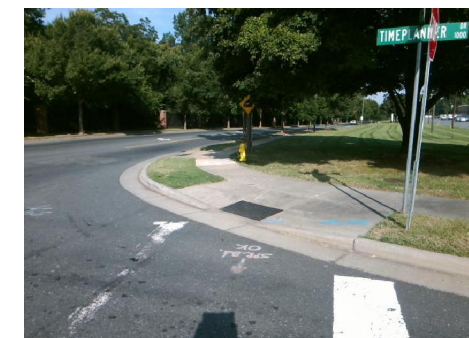
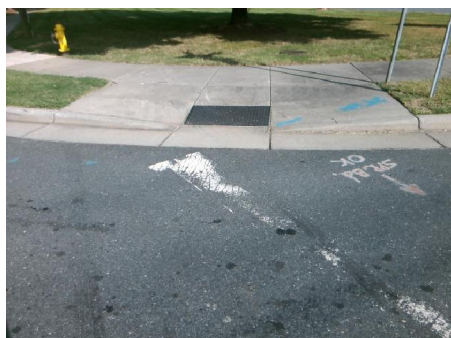
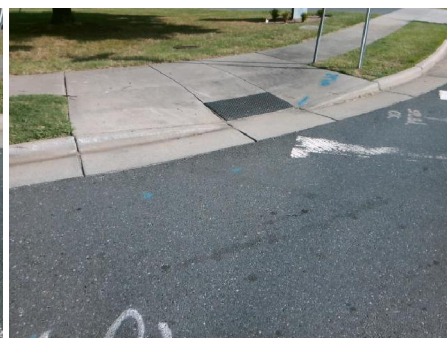
Compliance	Description	Data	Compliance	Description	Data
N/A	Ramp Length (in)	60.0	No	Ramp Slope (%)	12.2
No	Ramp Width (in)	43.5	No	Ramp XSlope (%)	2.7
N/A	Flare Type LT	N/A	N/A	Flare Type RT	N/A
N/A	Flare Slope LT (%)	N/A	N/A	Flare Slope RT (%)	N/A
N/A	Flare Traversable LT?	N/A	N/A	Flare Traversable RT?	N/A
N/A	Landing Length (in)	N/A	N/A	DWS Provided?	N/A
N/A	Landing Width (in)	N/A	N/A	DWS Contrast?	N/A
N/A	Landing Slope (%)	N/A	N/A	DWS Length (in)	N/A
N/A	Landing X Slope (%)	N/A	N/A	DWS Full Width?	N/A
N/A	Landing Curb? (Y/N)	N/A	N/A	DWS Offset (in)	N/A
N/A	Shared Landing?	N/A			
N/A	Gutter Ponding?	N/A	N/A	Gutter Slope (%)	N/A
N/A	Gutter Lip Ht (in)	N/A	N/A	Gutter X Slope (%)	N/A
N/A	Painted X Walk1?	No	N/A	Painted X Walk2?	N/A
	X Walk 1 Direction	To E		X Walk 2 Direction	N/A
N/A	X Walk 1 Width (in)	N/A	N/A	X Walk 2 Width (in)	N/A
	X Walk 1 Slope (%)	2.0		X Walk 2 Slope (%)	N/A
	X Walk 1 X Slope (%)	0.8		X Walk 2 X Slope (%)	N/A

N/A	Ramp inside XWalk1?	N/A	N/A	Ramp inside XWalk2?	N/A
	Road Slope (%)	N/A	N/A	Clear Space?	N/A
	Road X Slope (%)	N/A	N/A	Clear Space to XWalk (in)	N/A
N/A	Any Obstructions?	N/A	N/A	Storm Grate/Utility Hazard?	N/A
	Obstruction Type			Storm Grate/Utility Type	
		N/A			N/A
			Yes	Surface Condition? (G/P)	Good

Possible Solutions:

Remove & Replace Entire Ramp.

R304.5.1, R304.2.2, R304.5.3
