Access Compliance Report

Public Rights-of-Way

(Curb Ramps)

| Intersection ID: 49394 | Main Street: BENGALI_CR | Cross Street: ROMANA_RED_LN | Location: NE |

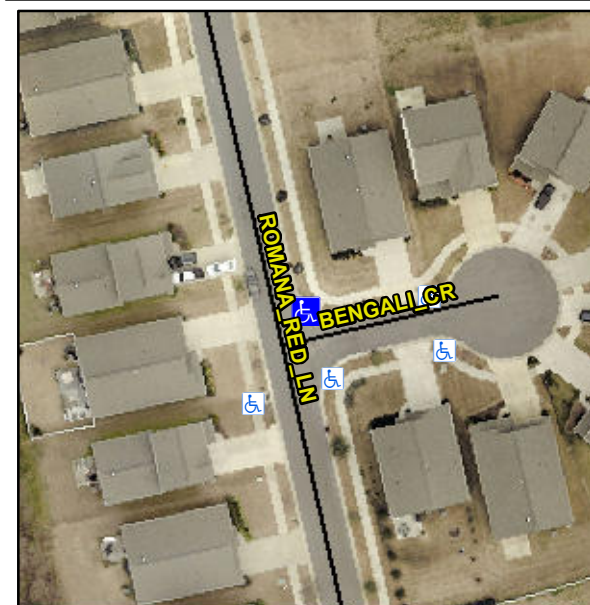
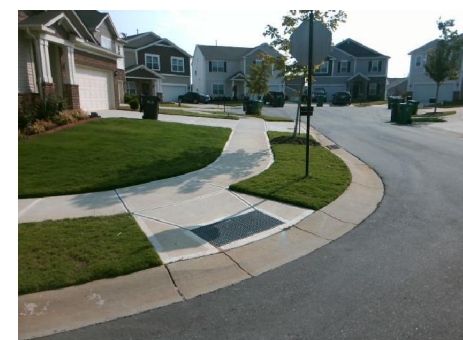
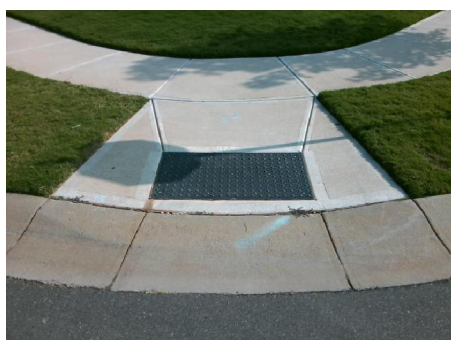
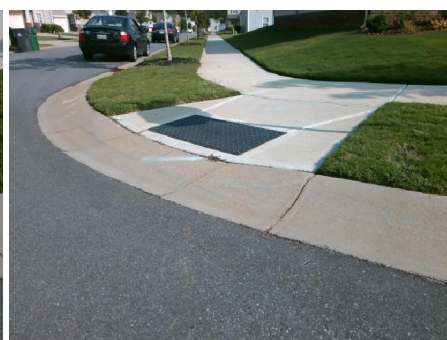
| ADA ID: 4C8116FEB93F | Ramp Type: PerpDiag | Initial Pass/Fail: Fail | Overall Compliance: No |

Not Found, R304.5.1, R304.5.3

| Compliance | Description | Data | Compliance | Description | Data |
|---|---|---|---|---|---|
| N/A | Ramp Length (in) | 71.0 | Yes | Ramp Slope (%) | 6.5 |
| No | Ramp Width (in) | 47.5 | No | Ramp XSlope (%) | 4.2 |

Remove & Replace Curb Ramp With Two New Directional Ramps or Equivalent.
