Access Compliance Report

Public Rights-of-Way

(Curb Ramps)

Intersection ID: N/A	Main Street: GALLERIA_BV	Cross Street: GALLERIA_COURT_DR	Location: SW
ADA ID: 4C9BA9171C41	Ramp Type: PerpDiag	Initial Pass/Fail: Fail	Overall Compliance: No
Codes/Mitigation Info/Possible Solution		Field Measurements/Component Compliance

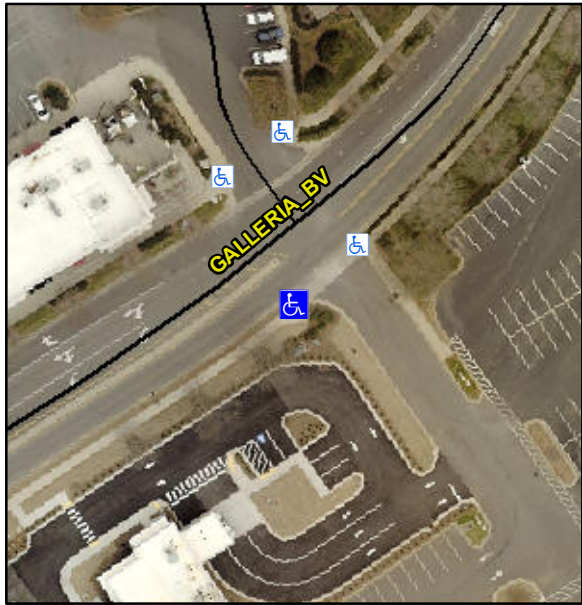
Compliance	Description	Data	Compliance	Description	Data
N/A	Ramp Length (in)	68.0	No	Ramp Slope (%)	13.5
Yes	Ramp Width (in)	48.0	Yes	Ramp XSlope (%)	0.2
N/A	Flare Type LT	N/A	N/A	Flare Type RT	N/A
N/A	Flare Slope LT (%)	N/A	N/A	Flare Slope RT (%)	N/A
N/A	Flare Traversable LT?	N/A	N/A	Flare Traversable RT?	N/A
N/A	Landing Length (in)	N/A	N/A	DWS Provided?	N/A
N/A	Landing Width (in)	N/A	N/A	DWS Contrast?	N/A
N/A	Landing Slope (%)	N/A	N/A	DWS Length (in)	N/A
N/A	Landing X Slope (%)	N/A	N/A	DWS Full Width?	N/A
N/A	Landing Curb? (Y/N)	N/A	N/A	DWS Offset (in)	N/A
N/A	Shared Landing?	N/A			
N/A	Gutter Ponding?	N/A	N/A	Gutter Slope (%)	N/A
N/A	Gutter Lip Ht (in)	N/A	N/A	Gutter X Slope (%)	N/A
N/A	Painted X Walk1?	No	N/A	Painted X Walk2?	No
	X Walk 1 Direction	To NE		X Walk 2 Direction	To NW
N/A	X Walk 1 Width (in)	N/A	N/A	X Walk 2 Width (in)	N/A
	X Walk 1 Slope (%)	1.5		X Walk 2 Slope (%)	1.9
	X Walk 1 X Slope (%)	1.3		X Walk 2 X Slope (%)	1.3

N/A	Ramp inside XWalk1?	N/A	N/A	Ramp inside XWalk2?	N/A
	Road Slope (%)	0.1	N/A	Clear Space?	N/A
	Road X Slope (%)	3.1	N/A	Clear Space to XWalk (in)	N/A
N/A	Any Obstructions?	N/A	N/A	Storm Grate/Utility Hazard?	N/A
	Obstruction Type			Storm Grate/Utility Type	
		N/A			N/A
			Yes	Surface Condition? (G/P)	Good

Possible Solutions:				
	Remove & Replace Curb Ramp With Two New Directional Ramps or Equivalent.				
	Surveyor Notes:				
	N/A				
	PROW/ADA:				
	R304.2.2				
	Street 1 Name	ENTRANCE			
	Stop Condition-Street 2	StopSign			
	Street 2 Name	GALLERIA BV			
	Stop Condition-Street 1	None			
Total Cost:		\$	3200.00
