# Access Compliance Report

## Public Rights-of-Way

### (Curb Ramps)

| Intersection ID: 19598 | Main Street: EMERYWOOD_DR | Cross Street: INGLESIDE_DR | Location: W |

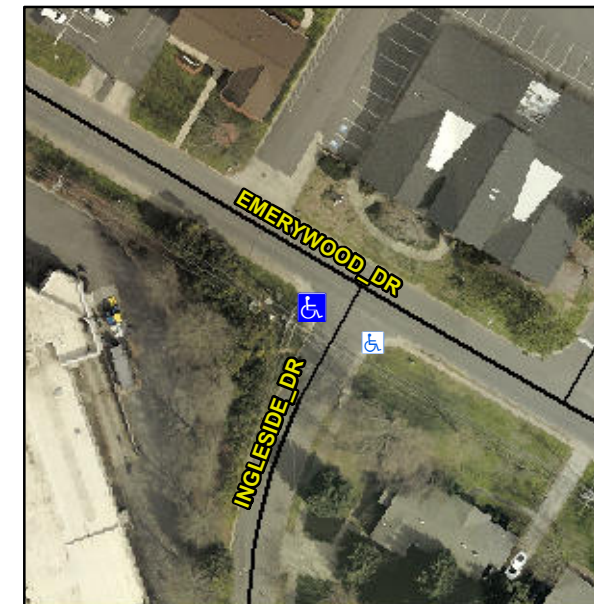
| ADA ID: 4CAD38B22857 | Ramp Type: PerpDiag | Initial Pass/Fail: Fail | Overall Compliance: No |

**Not Found, R304.2.2, R304.5.3**

| Compliance | Description | Data | Compliance | Description | Data |
|---|---|---|---|---|---|
| N/A | Ramp Length (in) | 60.0 | No | Ramp Slope (%) | 8.7 |
| Yes | Ramp Width (in) | 48.0 | No | Ramp XSlope (%) | 5.7 |

**Remove & Replace Curb Ramp With Two New Directional Ramps or Equivalent.**

Total Cost: \$ 3200.00
