# Access Compliance Report

## Public Rights-of-Way

### (Curb Ramps)

Intersection ID: N/A	Main Street: GLENBURN_LN	Cross Street: KELYN_HILLS_DR	Location: NW
ADA ID: 4CAF61A3D065	Ramp Type: PerpDiag	Initial Pass/Fail: Fail	Overall Compliance: No
Codes/Mitigation Info/Possible Solution		Field Measurements/Component Compliance

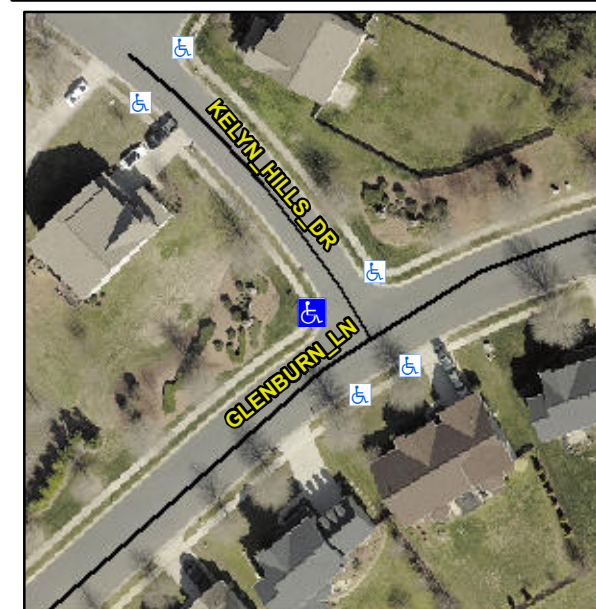
**Not Found, R304.5.1, R304.2.2, R304.5.3**

Compliance	Description	Data	Compliance	Description	Data
N/A	Ramp Length (in)	47.0	No	Ramp Slope (%)	9.3
No	Ramp Width (in)	39.0	No	Ramp XSlope (%)	8.2
N/A	Flare Type LT	N/A	N/A	Flare Type RT	N/A
N/A	Flare Slope LT (%)	N/A	N/A	Flare Slope RT (%)	N/A
N/A	Flare Traversable LT?	N/A	N/A	Flare Traversable RT?	N/A
N/A	Landing Length (in)	N/A	N/A	DWS Provided?	N/A
N/A	Landing Width (in)	N/A	N/A	DWS Contrast?	N/A
N/A	Landing Slope (%)	N/A	N/A	DWS Length (in)	N/A
N/A	Landing X Slope (%)	N/A	N/A	DWS Full Width?	N/A
N/A	Landing Curb? (Y/N)	N/A	N/A	DWS Offset (in)	N/A
N/A	Shared Landing?	N/A			
N/A	Gutter Ponding?	N/A	N/A	Gutter Slope (%)	N/A
N/A	Gutter Lip Ht (in)	N/A	N/A	Gutter X Slope (%)	N/A
N/A	Painted X Walk1?	No	N/A	Painted X Walk2?	No
	X Walk 1 Direction	To SE		X Walk 2 Direction	To NE
N/A	X Walk 1 Width (in)	N/A	N/A	X Walk 2 Width (in)	N/A
	X Walk 1 Slope (%)	5.7		X Walk 2 Slope (%)	7.5
	X Walk 1 X Slope (%)	5.8		X Walk 2 X Slope (%)	5.0

N/A	Ramp inside XWalk1?	N/A	N/A	Ramp inside XWalk2?	N/A
	Road Slope (%)	6.4	N/A	Clear Space?	N/A
	Road X Slope (%)	3.5	N/A	Clear Space to XWalk (in)	N/A
N/A	Any Obstructions?	N/A	N/A	Storm Grate/Utility Hazard?	N/A
	Obstruction Type			Storm Grate/Utility Type	
		N/A			N/A
			Yes	Surface Condition? (G/P)	Good

**Remove & Replace Curb Ramp With Two New Directional Ramps or Equivalent.**
