Access Compliance Report Public Rights-of-Way (Curb Ramps)

Intersection ID: 47116 Main Street: MCKEE_FOREST_CT Cross Street: CARPENTER_CABIN_DR Location: N

ADA ID: 4CB08E8B9DEC Ramp Type: Perp Initial Pass/Fail: Fail Overall Compliance: No Severity Score: 1.25

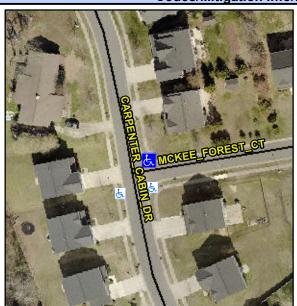
Field Measurements/Component Compliance							
Comp	liance Description	Data	Comp	liance	Description	Data	
N/A	Ramp Length (in)	69.0	Yes	Ramp	Slope (%)	7.3	
Yes	Ramp Width (in)	48.0	No	Ramp	XSlope (%)	2.7	
N/A	Flare Type LT	N/A	N/A	Flare	Type RT	N/A	
N/A	Flare Slope LT (%)	N/A	N/A	Flare	Slope RT (%)	N/A	
N/A	Flare Traversable LT?	N/A	N/A	Flare	Traversable RT?	N/A	
N/A	Landing Length (in)	N/A	N/A	DWS	Provided?	N/A	
N/A	Landing Width (in)	N/A	N/A	DWS	Contrast?	N/A	
N/A	Landing Slope (%)	N/A	N/A	DWS	Length (in)	N/A	
N/A	Landing X Slope (%)	N/A	N/A	DWS	Full Width?	N/A	
N/A	Landing Curb? (Y/N)	N/A	N/A	DWS	Offset (in)	N/A	
N/A	Shared Landing?	N/A					
N/A	Gutter Ponding?	N/A	N/A	Gutte	Slope (%)	N/A	
N/A	Gutter Lip Ht (in)	N/A	N/A	Gutte	X Slope (%)	N/A	
N/A	Painted X Walk1?	No	N/A	Painte	ed X Walk2?	N/A	
	X Walk 1 Direction	To S		X Wal	k 2 Direction	N/A	
N/A	X Walk 1 Width (in)	N/A	N/A	X Wal	k 2 Width (in)	N/A	
	X Walk 1 Slope (%)	3.8		X Wal	k 2 Slope (%)	N/A

X Walk 1 X Slope (%)	1.2		X Wal	k 2 X Slope (%)	N/A	
N/A	Ramp inside XWalk1?	N/A	N/A	Ramp	inside XWalk2?	N/A	
	Road Slope (%)	N/A	N/A	Clear	Space?	N/A	
	Road X Slope (%)	N/A	N/A	Clear	Space to XWalk (in)	N/A	
N/A	Any Obstructions?	N/A	N/A	Storm	Grate/Utility Hazard?	N/A	
	Obstruction Type			Storm	Grate/Utility Type		
		N/A				N/A	
			Yes	Surfac	ce Condition? (G/P)	Good

COCIDIO COIGNION	
Possible Solutions:	Com
Remove & Replace Entire Ramp.	N/A
•	Yes
	N/A
	N/A
	N/A
	N/A
Surveyor Notes:	N/A
N/A	N/A
	N/A
	N/A
	N/A
PROW/ADA:	N/A
Not Found, R304.5.3	N/A
·	N/A
	N/A
	N/A
