Intersection ID: 20507	Main Street: SARDIS_RD	Cross Street: BOYCE_RD	Location:	NE
ADA ID: 4CB8663A76F8	Ramp Type: PerpDiag	Initial Pass/Fail: Fail	Overall Compliance: No	Severity Score: 33.75

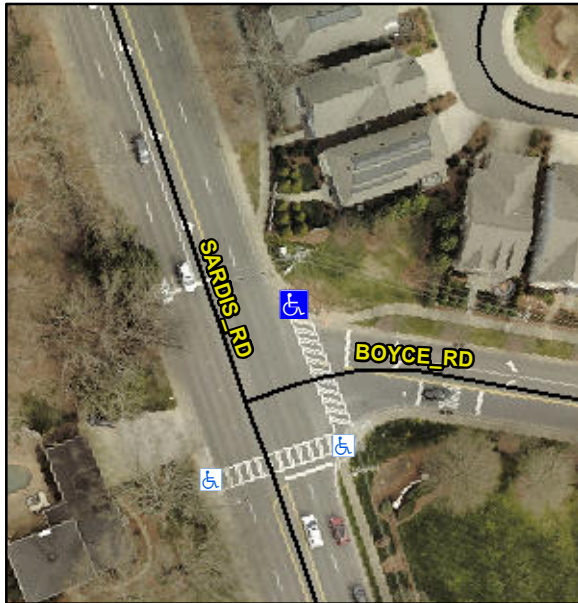
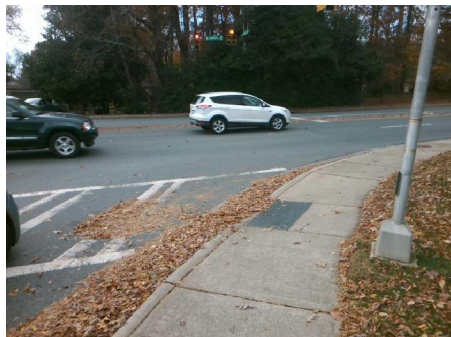
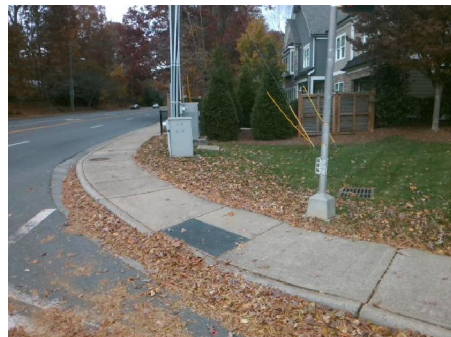
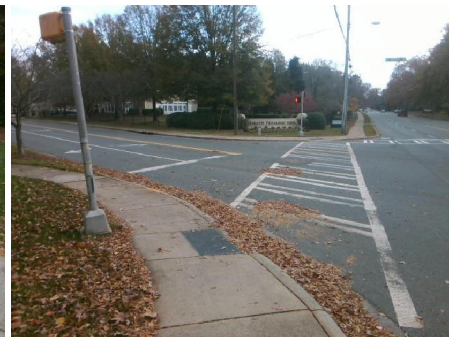
**Not Found, R304.5.1, R304.2.2,
R304.5.3**

Compliance	Description	Data	Compliance	Description	Data
N/A	Ramp Length (in)	59.0	No	Ramp Slope (%)	9.3
No	Ramp Width (in)	46.0	No	Ramp XSlope (%)	5.1
N/A	Flare Type LT	N/A	N/A	Flare Type RT	N/A
N/A	Flare Slope LT (%)	N/A	N/A	Flare Slope RT (%)	N/A
N/A	Flare Traversable LT?	N/A	N/A	Flare Traversable RT?	N/A
N/A	Landing Length (in)	N/A	N/A	DWS Provided?	N/A
N/A	Landing Width (in)	N/A	N/A	DWS Contrast?	N/A
N/A	Landing Slope (%)	N/A	N/A	DWS Length (in)	N/A
N/A	Landing X Slope (%)	N/A	N/A	DWS Full Width?	N/A
N/A	Landing Curb? (Y/N)	N/A	N/A	DWS Offset (in)	N/A
N/A	Shared Landing?	N/A			
N/A	Gutter Ponding?	N/A	N/A	Gutter Slope (%)	N/A
N/A	Gutter Lip Ht (in)	N/A	N/A	Gutter X Slope (%)	N/A
N/A	Painted X Walk1?	No	N/A	Painted X Walk2?	Yes
	X Walk 1 Direction	To W		X Walk 2 Direction	To S
N/A	X Walk 1 Width (in)	N/A	N/A	X Walk 2 Width (in)	112.0
	X Walk 1 Slope (%)	4.0		X Walk 2 Slope (%)	0.4
	X Walk 1 X Slope (%)	2.1		X Walk 2 X Slope (%)	3.9

N/A	Ramp inside XWalk1?	N/A	N/A	Ramp inside XWalk2?	Yes
	Road Slope (%)	4.2	N/A	Clear Space?	N/A
	Road X Slope (%)	3.8	N/A	Clear Space to XWalk (in)	N/A
N/A	Any Obstructions?	N/A	N/A	Storm Grate/Utility Hazard?	N/A
	Obstruction Type			Storm Grate/Utility Type	
		N/A			N/A
			Yes	Surface Condition? (G/P)	Good

Remove & Replace Curb Ramp With Two New Directional Ramps or Equivalent.
