Access Compliance Report

Public Rights-of-Way

(Curb Ramps)

Intersection ID: N/A	Main Street: SPRINGWOOD_ESTATE_DR	Cross Street: BELVEDERE_CASTLE_DR	Location: SE
ADA ID: 4CBA44DFA1E2	Ramp Type: Perp	Initial Pass/Fail: Fail	Overall Compliance: No
Codes/Mitigation Info/Possible Solution		Field Measurements/Component Compliance	
Severity Score: 12.5

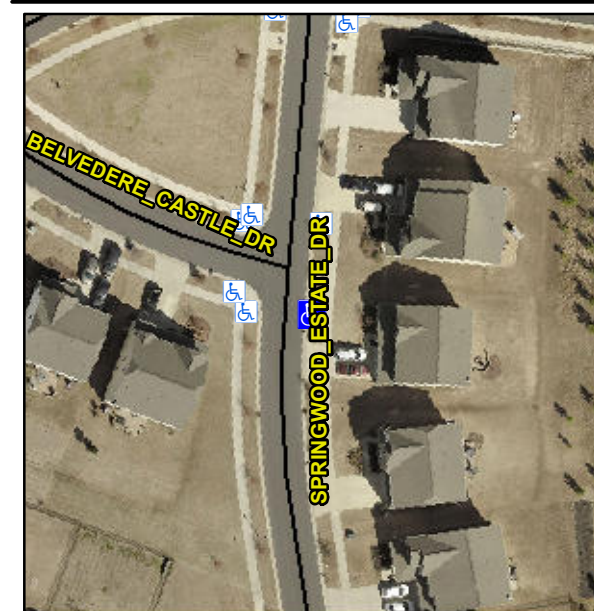
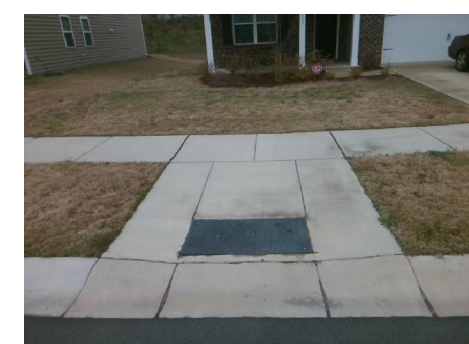
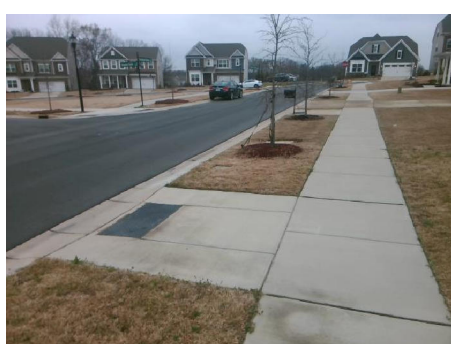
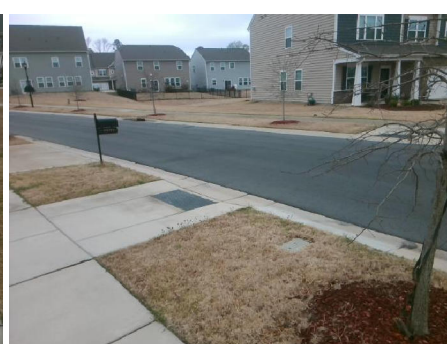
Not Found, R304.5.3

Compliance	Description	Data	Compliance	Description	Data
N/A	Ramp Length (in)	95.0	Yes	Ramp Slope (%)	5.0
Yes	Ramp Width (in)	48.0	No	Ramp XSlope (%)	5.2
N/A	Flare Type LT	N/A	N/A	Flare Type RT	N/A
N/A	Flare Slope LT (%)	N/A	N/A	Flare Slope RT (%)	N/A
N/A	Flare Traversable LT?	N/A	N/A	Flare Traversable RT?	N/A
N/A	Landing Length (in)	N/A	N/A	DWS Provided?	N/A
N/A	Landing Width (in)	N/A	N/A	DWS Contrast?	N/A
N/A	Landing Slope (%)	N/A	N/A	DWS Length (in)	N/A
N/A	Landing X Slope (%)	N/A	N/A	DWS Full Width?	N/A
N/A	Landing Curb? (Y/N)	N/A	N/A	DWS Offset (in)	N/A
N/A	Shared Landing?	N/A			
N/A	Gutter Ponding?	N/A	N/A	Gutter Slope (%)	N/A
N/A	Gutter Lip Ht (in)	N/A	N/A	Gutter X Slope (%)	N/A
N/A	Painted X Walk1?	No	N/A	Painted X Walk2?	N/A
	X Walk 1 Direction	To W		X Walk 2 Direction	N/A
N/A	X Walk 1 Width (in)	N/A	N/A	X Walk 2 Width (in)	N/A
	X Walk 1 Slope (%)	2.1		X Walk 2 Slope (%)	N/A
	X Walk 1 X Slope (%)	1.4		X Walk 2 X Slope (%)	N/A

N/A	Ramp inside XWalk1?	N/A	N/A	Ramp inside XWalk2?	N/A
	Road Slope (%)	N/A	N/A	Clear Space?	N/A
	Road X Slope (%)	N/A	N/A	Clear Space to XWalk (in)	N/A
N/A	Any Obstructions?	N/A	N/A	Storm Grate/Utility Hazard?	N/A
	Obstruction Type			Storm Grate/Utility Type	
		N/A			N/A
			Yes	Surface Condition? (G/P)	Good

Remove & Replace Entire Ramp.

Total Cost: \$ 1850.00
