## Access Compliance Report Public Rights-of-Way (Curb Ramps)

Intersection ID: 24591 Main Street: REA\_CROFT\_DR Cross Street: SPRINGSIDE\_LN Location: SW

ADA ID: 4CBF7A03A6E8 Ramp Type: PerpDiag Initial Pass/Fail: Fail Overall Compliance: No Severity Score: 12.5

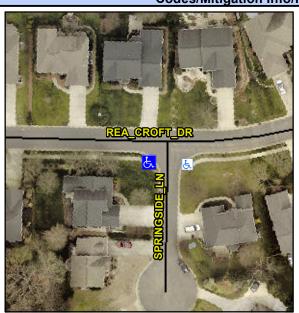
Not Found, R304.5.3

Comp	liance Description	Data	Compliance		Description	Data
N/A	Ramp Length (in)	94.0	Yes		Slope (%)	7.5
Yes	Ramp Length (in)	48.0	No		o XSlope (%)	7.5 5.7
N/A	Flare Type LT	46.0 N/A	N/A		Type RT	N/A
N/A	**	N/A	N/A N/A		· ·	N/A
	Flare Slope LT (%)	N/A N/A	N/A N/A		Slope RT (%)	
N/A	Flare Traversable LT?				Traversable RT?	N/A
N/A	Landing Length (in)	N/A	N/A		Provided?	N/A
N/A	Landing Width (in)	N/A	N/A		Contrast?	N/A
N/A	Landing Slope (%)	N/A	N/A		Length (in)	N/A
N/A	Landing X Slope (%)	N/A	N/A		Full Width?	N/A
N/A	Landing Curb? (Y/N)	N/A	N/A	DWS	Offset (in)	N/A
N/A	Shared Landing?	N/A				
N/A	Gutter Ponding?	N/A	N/A	Gutte	er Slope (%)	N/A
N/A	Gutter Lip Ht (in)	N/A	N/A	Gutte	er X Slope (%)	N/A
N/A	Painted X Walk1?	No	N/A	Paint	ed X Walk2?	No
	X Walk 1 Direction	To SE		X Wa	lk 2 Direction	To NE
N/A	X Walk 1 Width (in)	N/A	N/A	X Wa	ılk 2 Width (in)	N/A
	X Walk 1 Slope (%)	0.3		X Wa	ılk 2 Slope (%)	2.8
	X Walk 1 X Slope (%)	3.1		X Wa	ılk 2 X Slope (%)	0.6

N/A	Ramp inside XWalk1?	N/A	N/A	Ram	p inside XWalk2?	N/A
	Road Slope (%)	3.5	N/A	Clea	Space?	N/A
	Road X Slope (%)	1.6	N/A	Clear	Space to XWalk (in)	N/A
N/A	Any Obstructions?	N/A	N/A	Storn	n Grate/Utility Hazard?	N/A
	Obstruction Type			Storn	n Grate/Utility Type	
		N/A				N/A
			Yes	Surfa	ice Condition? (G/P)	Good

Remove & Replace Curb Ramp With Two New Directional Ramps or Equivalent.
