Access Compliance Report Public Rights-of-Way (Curb Ramps)

Main Street: PARK RD Cross Street: N/A Intersection ID: 10033933 Location: SW Initial Pass/Fail: Fail **Overall Compliance: No** ADA ID: 4CC19D74C602 Ramp Type: Perp Severity Score: 21.25

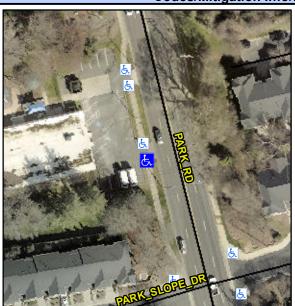
Ramp Slope (%)

Ramp XSlope (%)

74.0

47.5

POSSIBLE SOLUTION		rieiu ivie
Possible Solutions:	Comp	liance Description
Remove & Replace Entire Ramp.	N/A	Ramp Length (in)
·	No	Ramp Width (in)
	N/A	Flare Type LT
	N/A	Flare Slope LT (%)
	N/A	Flare Traversable L
	N/A	Landing Length (in)
Surveyor Notes:	N/A	Landing Width (in)
N/A	N/A	Landing Slope (%)
	N/A	Landing X Slope (%
	N/A	Landing Curb? (Y/N
	N/A	Shared Landing?
PROW/ADA:	N/A	Gutter Ponding?
Not Found, R304.5.1, R304.5.3	N/A	Gutter Lip Ht (in)
	N/A	Painted X Walk1?
		X Walk 1 Direction
	N/A	X Walk 1 Width (in)
		X Walk 1 Slope (%)
		X Walk 1 X Slope (%
	N/A	Ramp inside XWalk
		Road Slope (%)

1850.00
