Intersection ID: 15073	Main Street: PUHLMAN_ST	Cross Street: WASHBURN_AV	Location:	NE
ADA ID: 4CC31A9D7966	Ramp Type: PerpDiag	Initial Pass/Fail: Fail	Overall Compliance: No	Severity Score: 46.25

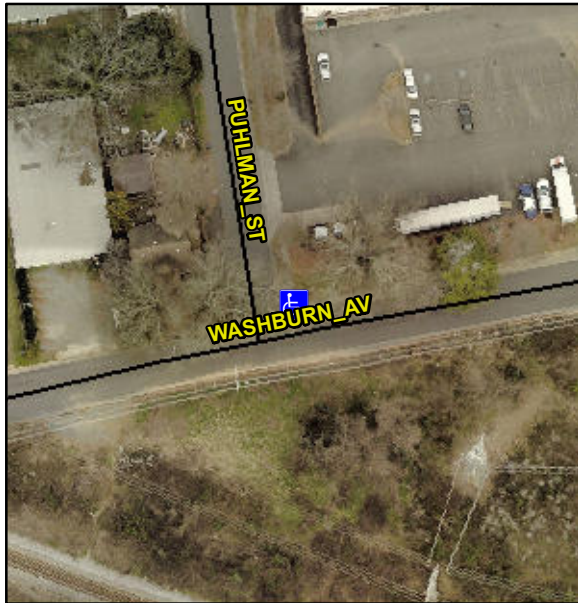
**Not Found, R304.5.1, R304.2.2,
R304.5.3**

Compliance	Description	Data	Compliance	Description	Data
N/A	Ramp Length (in)	58.0	No	Ramp Slope (%)	8.6
No	Ramp Width (in)	39.0	No	Ramp XSlope (%)	7.1
N/A	Flare Type LT	N/A	N/A	Flare Type RT	N/A
N/A	Flare Slope LT (%)	N/A	N/A	Flare Slope RT (%)	N/A
N/A	Flare Traversable LT?	N/A	N/A	Flare Traversable RT?	N/A
N/A	Landing Length (in)	N/A	N/A	DWS Provided?	N/A
N/A	Landing Width (in)	N/A	N/A	DWS Contrast?	N/A
N/A	Landing Slope (%)	N/A	N/A	DWS Length (in)	N/A
N/A	Landing X Slope (%)	N/A	N/A	DWS Full Width?	N/A
N/A	Landing Curb? (Y/N)	N/A	N/A	DWS Offset (in)	N/A
N/A	Shared Landing?	N/A			
N/A	Gutter Ponding?	N/A	N/A	Gutter Slope (%)	N/A
N/A	Gutter Lip Ht (in)	N/A	N/A	Gutter X Slope (%)	N/A
N/A	Painted X Walk1?	No	N/A	Painted X Walk2?	No
	X Walk 1 Direction	To W		X Walk 2 Direction	To S
N/A	X Walk 1 Width (in)	N/A	N/A	X Walk 2 Width (in)	N/A
	X Walk 1 Slope (%)	1.1		X Walk 2 Slope (%)	8.6
	X Walk 1 X Slope (%)	10.7		X Walk 2 X Slope (%)	1.2

N/A	Ramp inside XWalk1?	N/A	N/A	Ramp inside XWalk2?	N/A
	Road Slope (%)	4.7	N/A	Clear Space?	N/A
	Road X Slope (%)	8.5	N/A	Clear Space to XWalk (in)	N/A
N/A	Any Obstructions?	N/A	N/A	Storm Grate/Utility Hazard?	N/A
	Obstruction Type			Storm Grate/Utility Type	
		N/A			N/A
			Yes	Surface Condition? (G/P)	Good

Remove & Replace Curb Ramp With Two New Directional Ramps or Equivalent.
