## **Access Compliance Report Public Rights-of-Way** (Curb Ramps)

Intersection ID: 16453 Main Street: MARVIN\_RD Cross Street: N\_WENDOVER\_RD Location: NE **ADA ID: 4CCC89B9A73B** Ramp Type: PerpDiag Initial Pass/Fail: Fail **Overall Compliance: No Severity Score:** 25

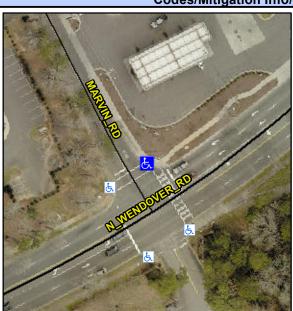
Field Measurements/Component Compliance					
Compliance Description		Data	Comp	liance Description	Data
N/A	Ramp Length (in)	84.0	Yes	Ramp Slope (%)	5.2
Yes	Ramp Width (in)	48.0	No	Ramp XSlope (%)	8.6
N/A	Flare Type LT	N/A	N/A	Flare Type RT	N/A
N/A	Flare Slope LT (%)	N/A	N/A	Flare Slope RT (%)	N/A
N/A	Flare Traversable LT?	N/A	N/A	Flare Traversable RT?	N/A
N/A	Landing Length (in)	N/A	N/A	DWS Provided?	N/A
N/A	Landing Width (in)	N/A	N/A	DWS Contrast?	N/A
N/A	Landing Slope (%)	N/A	N/A	DWS Length (in)	N/A
N/A	Landing X Slope (%)	N/A	N/A	DWS Full Width?	N/A
N/A	Landing Curb? (Y/N)	N/A	N/A	DWS Offset (in)	N/A
N/A	Shared Landing?	N/A			
N/A	Gutter Ponding?	N/A	N/A	Gutter Slope (%)	N/A
N/A	Gutter Lip Ht (in)	N/A	N/A	Gutter X Slope (%)	N/A
N/A	Painted X Walk1?	Yes	N/A	Painted X Walk2?	Yes
	X Walk 1 Direction	To W		X Walk 2 Direction	To S
N/A	X Walk 1 Width (in)	105.0	N/A	X Walk 2 Width (in)	87.0
	X Walk 1 Slope (%)	1.6		X Walk 2 Slope (%)	0.5

X Walk 1 X Slope (%)	0.8		X Walk 2 X Slope (%)	0.4
N/A	Ramp inside XWalk1?	Yes	N/A	Ramp inside XWalk2?	No
	Road Slope (%)	0.9	N/A	Clear Space?	N/A
	Road X Slope (%)	1.9	N/A	Clear Space to XWalk (in)	N/A
N/A	Any Obstructions?	N/A	N/A	Storm Grate/Utility Hazard?	N/A
	Obstruction Type			Storm Grate/Utility Type	
		N/A			N/A
			Yes	Surface Condition? (G/P)	Good

Possible Solutions: Remove & Replace Curb Ramp With Two New Directional Ramps or **Equivalent. Restripe Crosswalk.** Surveyor Notes: N/A PROW/ADA: Not Found, R304.5.3
