# Access Compliance Report

## Public Rights-of-Way

Intersection ID: 10034413	Main Street: PIERSON_DR	Cross Street: N/A	Location: SW
ADA ID: 4CDA174E7AB7	Ramp Type: Perp	Initial Pass/Fail: Fail	Overall Compliance: No
		Severity Score: 22.5

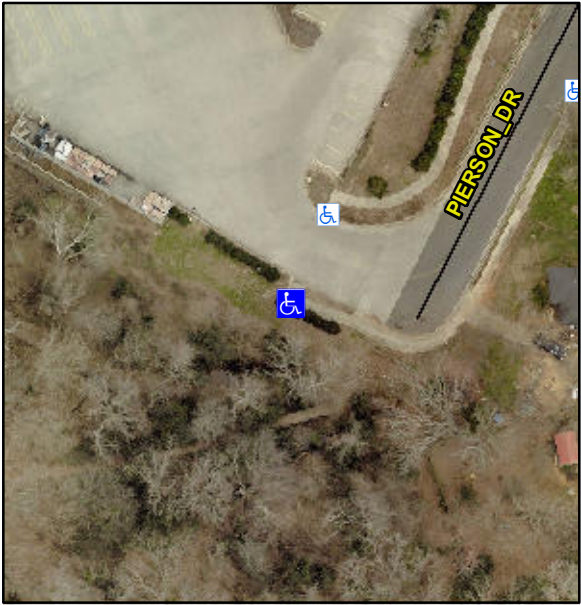
Possible Solutions:		<b>Compliance</b>	<b>Description</b>	<b>Data</b>
	<b>Remove &amp; Replace Entire Ramp.</b>		<b>No</b>	Ramp Length (in)	72.0
			<b>No</b>	Ramp Width (in)	47.0
			<b>N/A</b>	Flare Type LT	N/A
			<b>N/A</b>	Flare Slope LT (%)	N/A
			<b>N/A</b>	Flare Traversable LT?	N/A
			<b>N/A</b>	Landing Length (in)	N/A
			<b>N/A</b>	Landing Width (in)	N/A
			<b>N/A</b>	Landing Slope (%)	N/A
			<b>N/A</b>	Landing X Slope (%)	N/A
<p>Surveyor Notes:</p> <p><b>N/A</b></p> <p>PROW/ADA:</p> <p><b>R304.5.1, R304.2.2, R304.5.3</b></p>			<b>N/A</b>	Flare Type RT	N/A
			<b>N/A</b>	Flare Slope RT (%)	N/A
			<b>N/A</b>	Flare Traversable RT?	N/A
			<b>N/A</b>	DWS Provided?	N/A
			<b>N/A</b>	DWS Contrast?	N/A
			<b>N/A</b>	DWS Length (in)	N/A
			<b>N/A</b>	DWS Full Width?	N/A
			<b>N/A</b>	DWS Offset (in)	N/A
			<b>N/A</b>	Shared Landing?	N/A

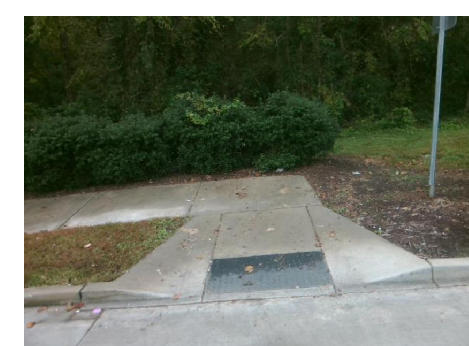
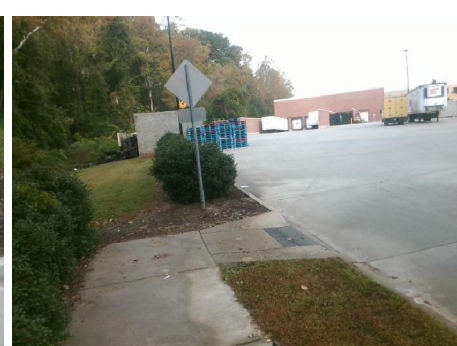
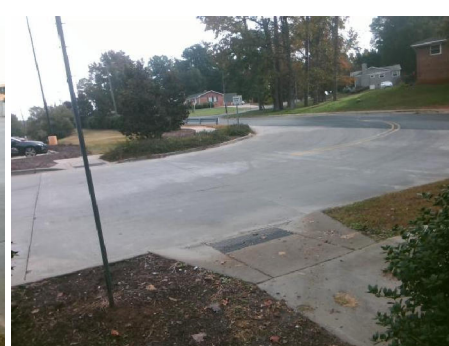
<b>N/A</b>	Gutter Ponding?	N/A
<p>Street 1 Name</p> <p>ENTRANCE</p> <p>Stop Condition-Street 2</p> <p>None</p> <p>Street 2 Name</p> <p>N/A</p> <p>Stop Condition-Street 1</p> <p>N/A</p>			<b>N/A</b>	Gutter Lip Ht (in)	N/A
			<b>No</b>	Painted X Walk1?	N/A
				X Walk 1 Direction	To NE
			<b>N/A</b>	X Walk 1 Width (in)	N/A
				X Walk 1 Slope (%)	5.7
				X Walk 1 X Slope (%)	2.2
			<b>N/A</b>	Ramp inside XWalk1?	N/A
			<b>N/A</b>	Road Slope (%)	N/A
			<b>N/A</b>	Road X Slope (%)	N/A
			<b>N/A</b>	Any Obstructions?	N/A
<p>Total Cost:</p> <p>\$ 1850.00</p>			<b>N/A</b>	Obstruction Type	
			<b>N/A</b>	Clear Space?	N/A
			<b>N/A</b>	Clear Space to XWalk (in)	N/A
			<b>N/A</b>	Storm Grate/Utility Hazard?	N/A
				Storm Grate/Utility Type	
			<b>N/A</b>		N/A
			<b>Yes</b>	Surface Condition? (G/P)	Good
